Milestone Inspection – Phase 1

Prepared for the Board of Directors for the
Cordova Green of Largo COA

8681, 8693, 8605 Bardmoor Blvd Seminole, FL 33777

November 6, 2023

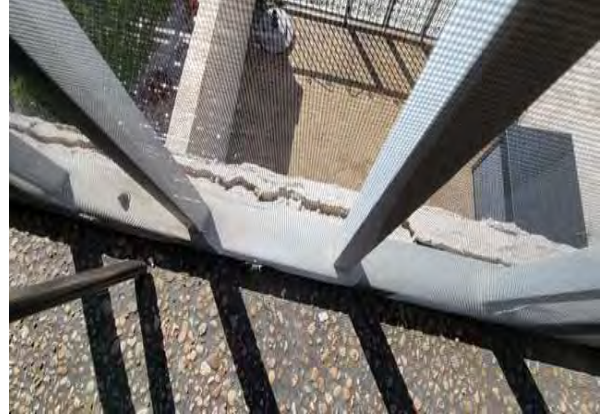
- Building 8681, Unit #503
 - Cracked Outer Edge of Balcony

12 Unit 503 Cracked Balcony

For the Exterior balconies, we recommend that the balconies have a Phase 2 destructive testing performed to determine if the noted areas are structurally compromised or not. We also recommend that 100% of the balconies are inspected for at a minimum thermal imaging or visual observation to get a better understanding of the pervasiveness of the damages found.

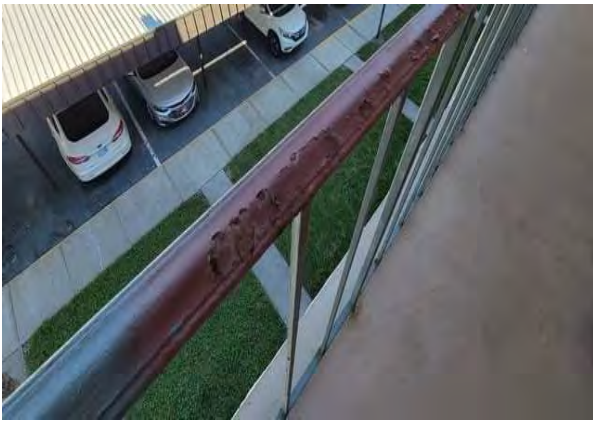
17 3rd Floor Rusted Rail

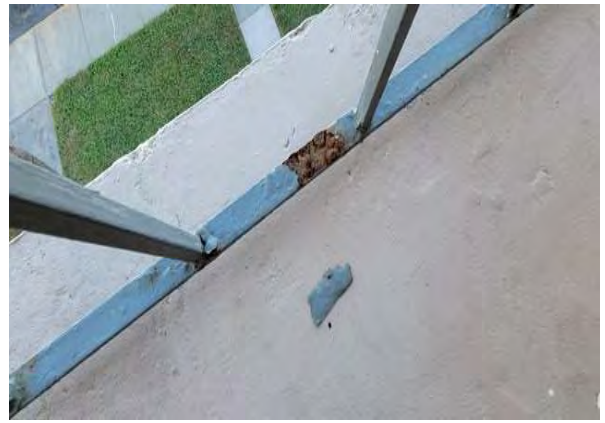
18 3rd Floor Rusted Rail

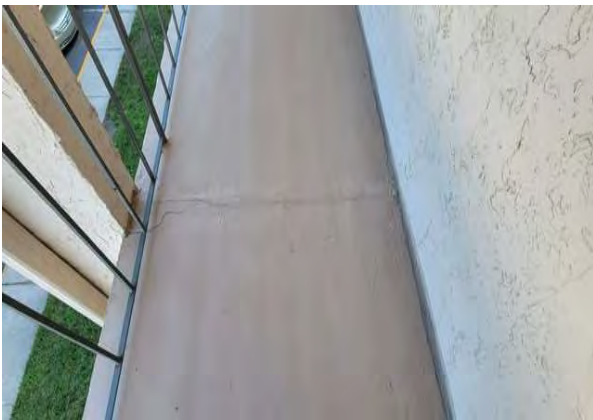
21 Cracked Walkway Near Unit 606 Overview

For the typical cracks observed in the concrete, we recommend that the proper cementitious and masonry-based repair material is used, with Beryl providing oversight to ensure the correct material was used in the repair. After repairs, we recommend that the painting/waterproofing schedule is strictly adhered to. As part of a yearly inspection, we recommend that any surficial cracks developing are sealed with elastomeric sealer between formal painting cycles.

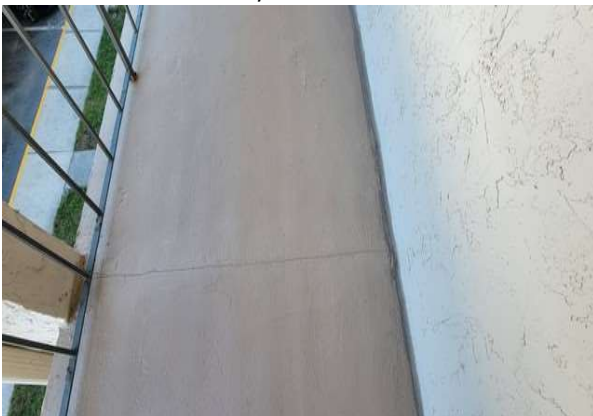
23 Cracked Walkway Near Unit 604 Overview

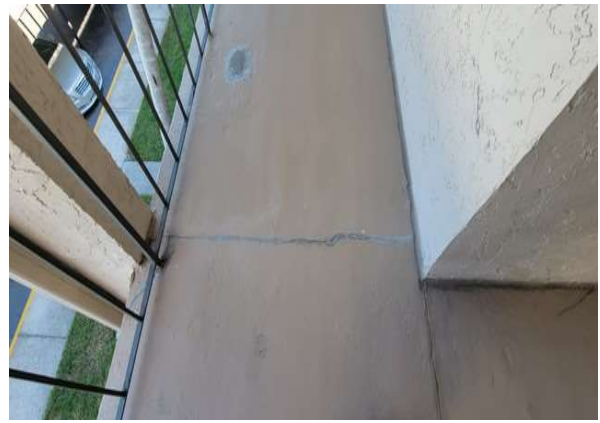
26 Cracked Walkway Near Elevator Lobby 3rd Floor Overview

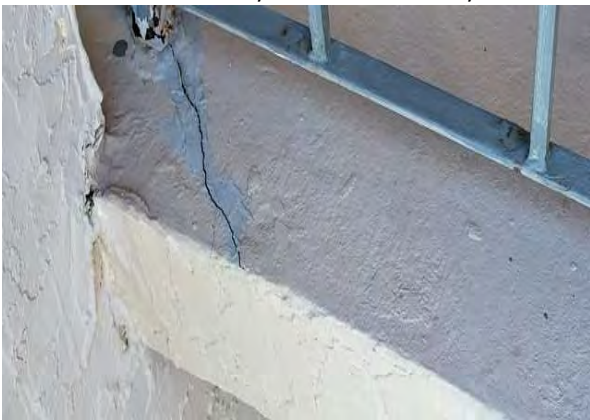
29 Cracked Walkway Near Elevator Lobby 3rd Floor

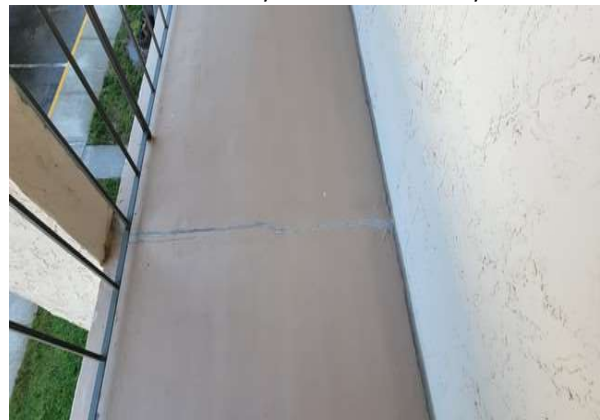
30 Cracked Walkway Near Unit 603 Overview

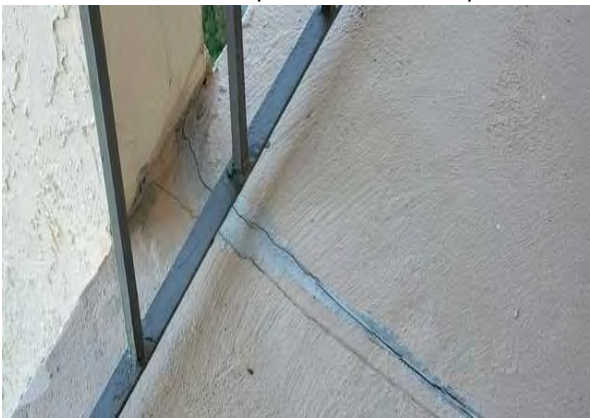
31 Cracked Walkway Near Unit 603

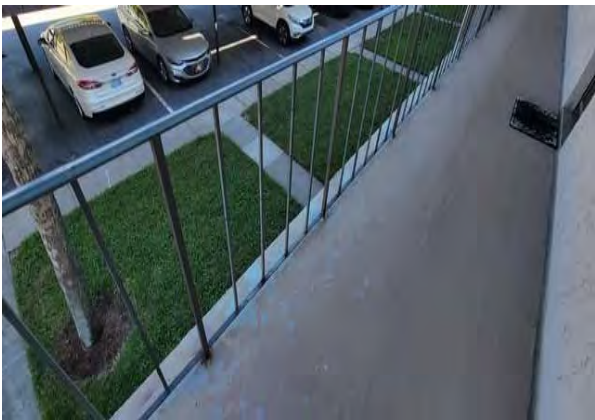
37 Rusty Handrail 2nd Floor Near Front Right Corner of Building

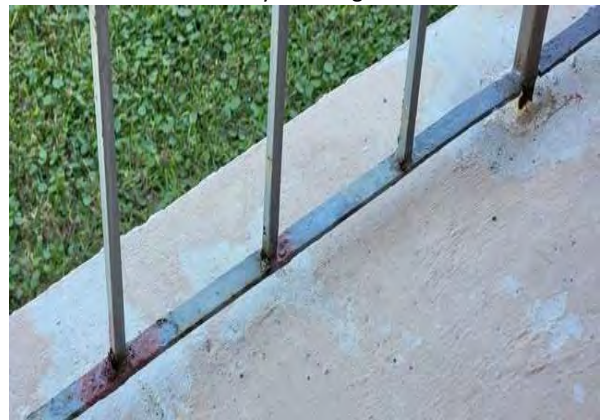
38 Rusty Handrail 2nd Floor Near Front Right Corner of Building

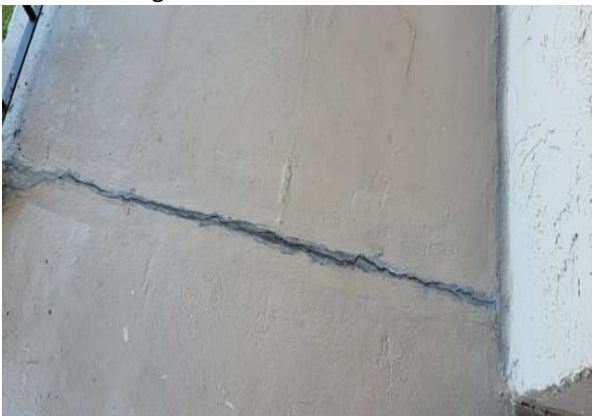
47 Cracked Walkway 2nd Floor Left of Elevator
Lobby

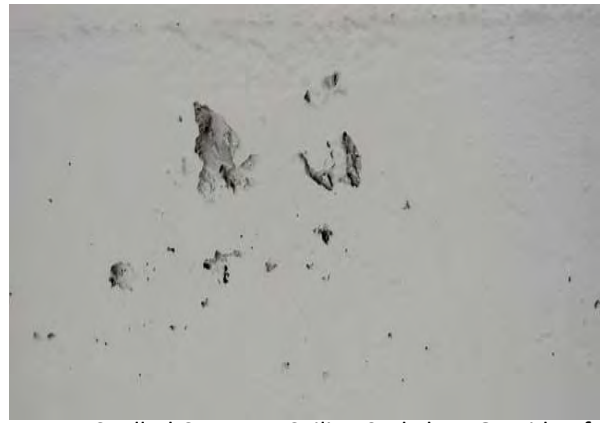
50 Spalled Concrete Ceiling 2nd Floor Outside of Electrical Room

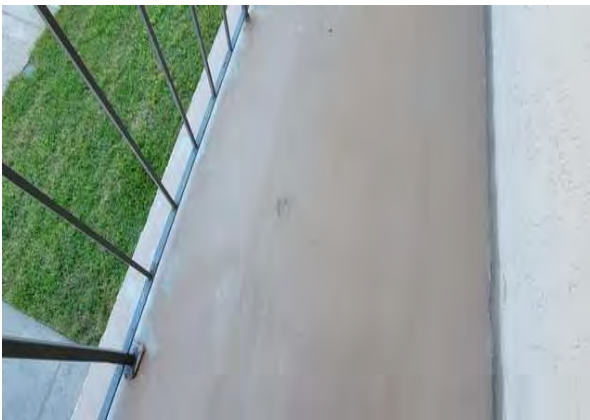
53 Damaged Concrete 2nd Floor Between Units 503 & 504 Overview

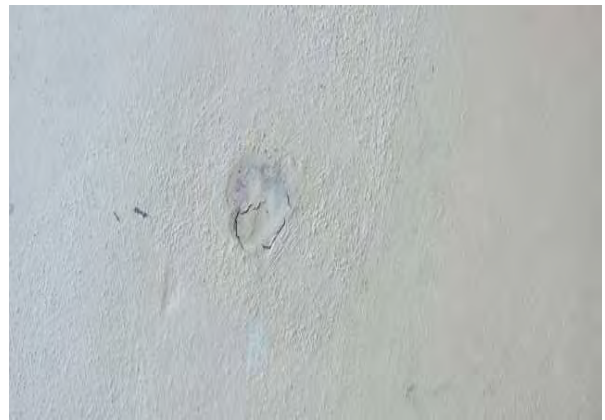
54 Damaged Concrete 2nd Floor Between Units 503 & 504

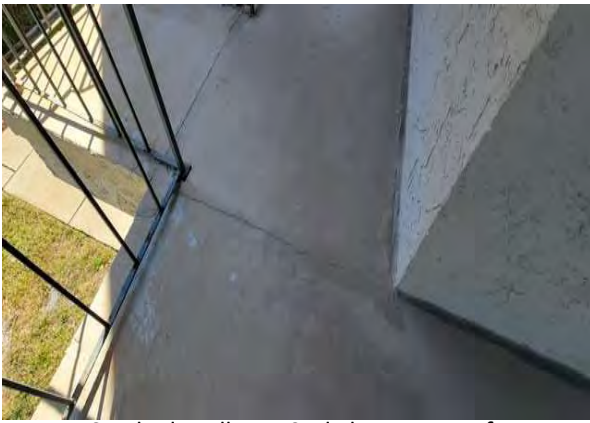
57 Cracked Walkway 2nd Floor Near Left Stairwell Overview

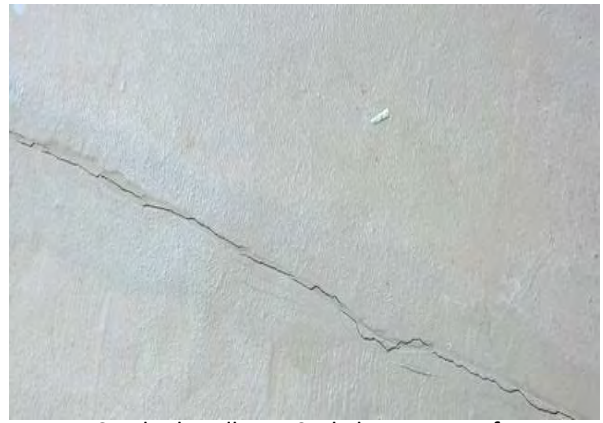
58 Cracked Walkway 2nd Floor Near Left Stairwell

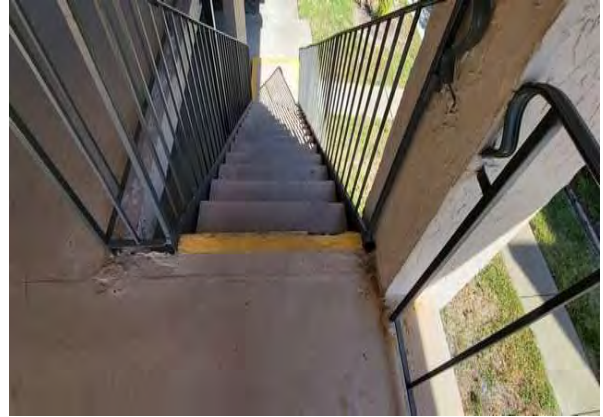
60 Damaged Walkway at Stairwell 2nd Floor Left Side Overview

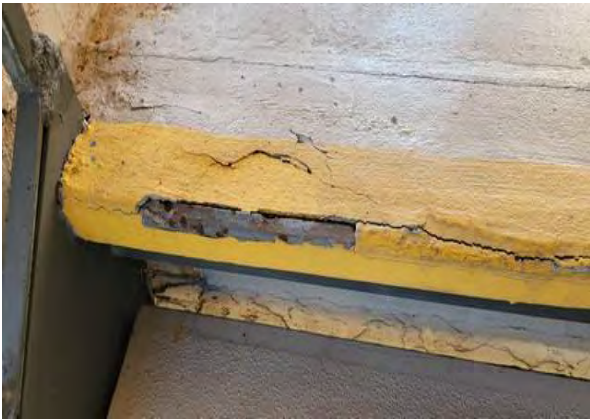
61 Damaged Walkway at Stairwell 2nd Floor Left Side

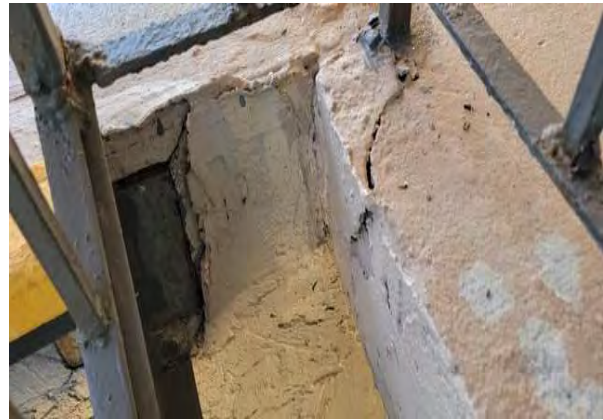
62 Damaged Walkway at Stairwell 2nd Floor Left Side

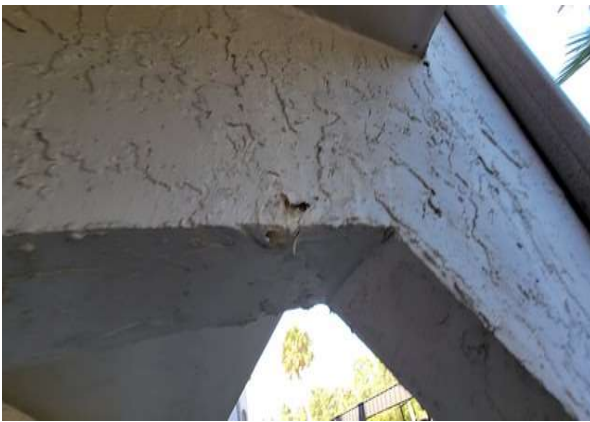
69 Damaged Stucco 1st Floor Near Unit 401

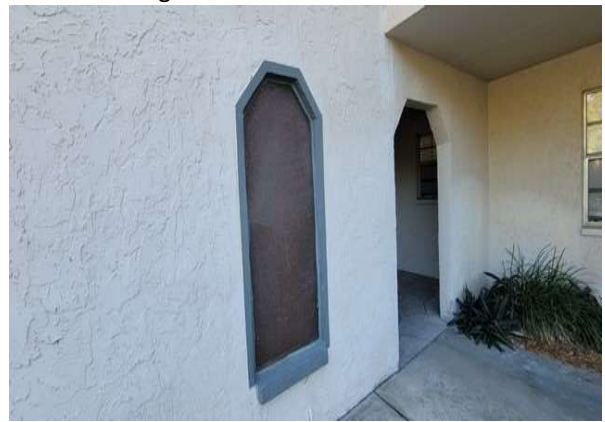
70 Broken Decroitive Window at 1st Floor Lobby Right Side Overview

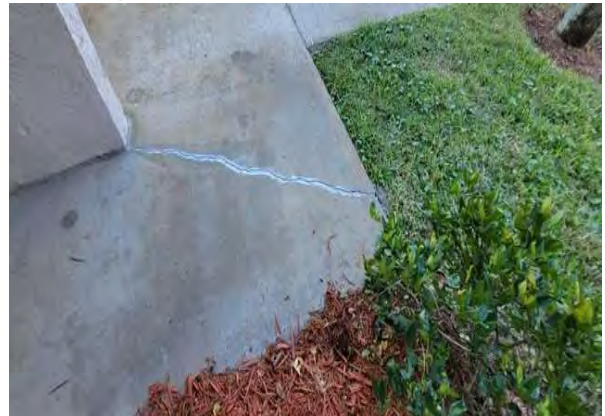
72 Cracked Sidewalk Front Right Corner of Building Overview

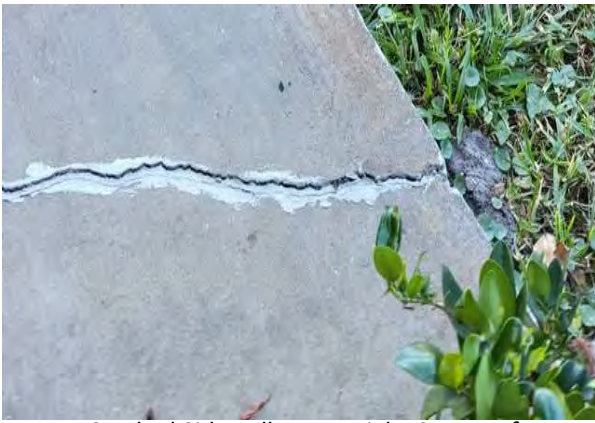
73 Cracked Sidewalk Front Right Corner of Building

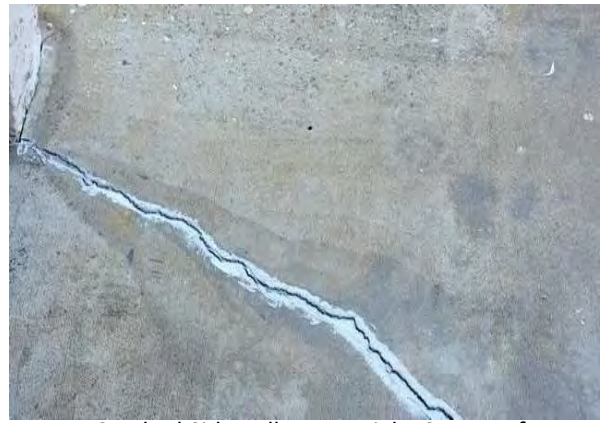
74 Cracked Sidewalk Front Right Corner of Building

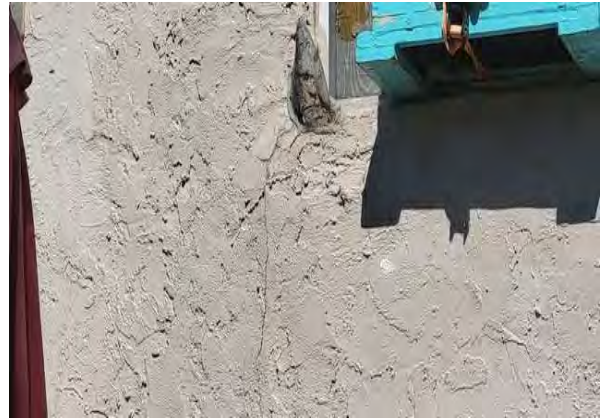
76 Cracked Stucco Rear Wall Between Units 401 & 501

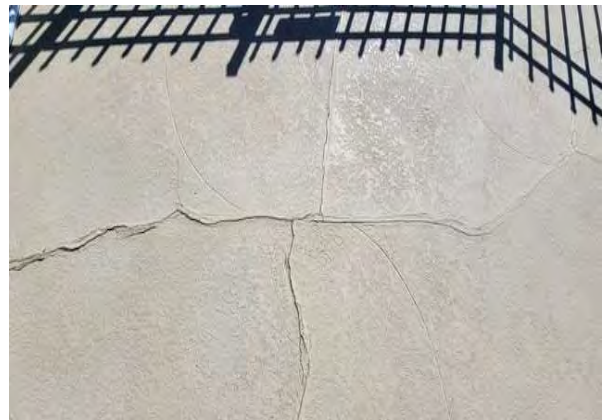
78 Cracked Pool Deck

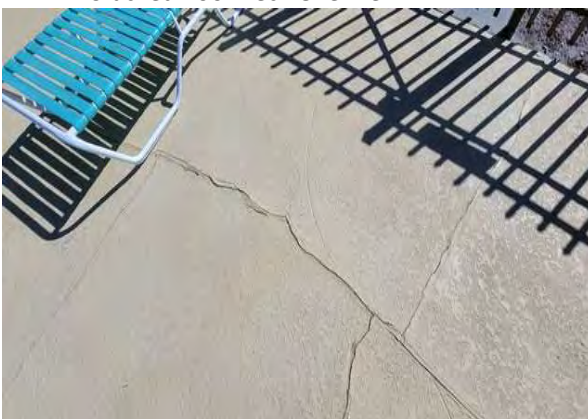
79 Cracked Pool Deck

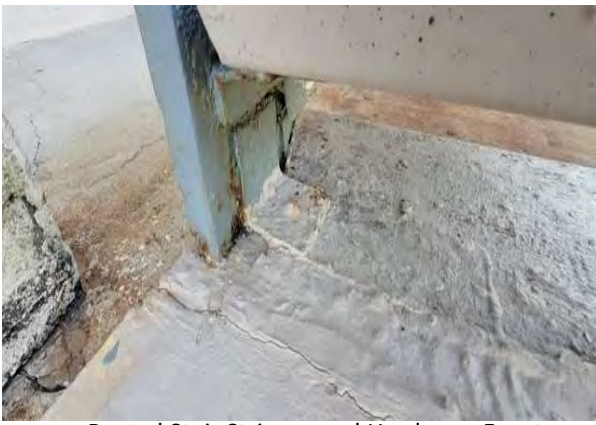
81 Rusted Stair Stringer and Hardware Front Right of Building

For the stairs, we recommend that the stairs have a Phase 2 destructive testing performed to determine if the noted areas are structurally compromised or not. When the breezeways/walkways are sealed, we recommend that the stairs are included to help prevent future structural issues caused by water infiltration as part of a preventative maintenance plan.

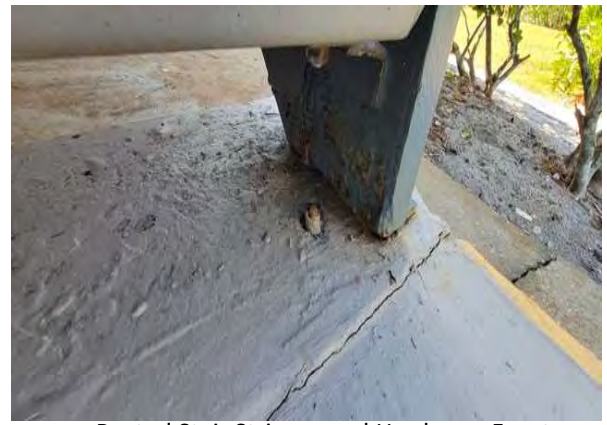
82 Rusted Stair Stringer and Hardware Front Right of Building

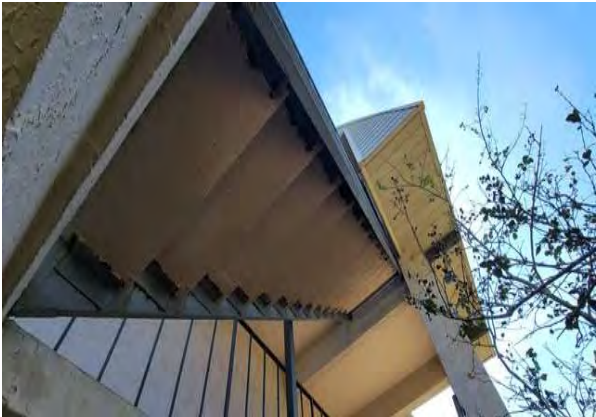
83 Rusted Tread Supports Stairs to 2nd Floor Front Right of Building Overview

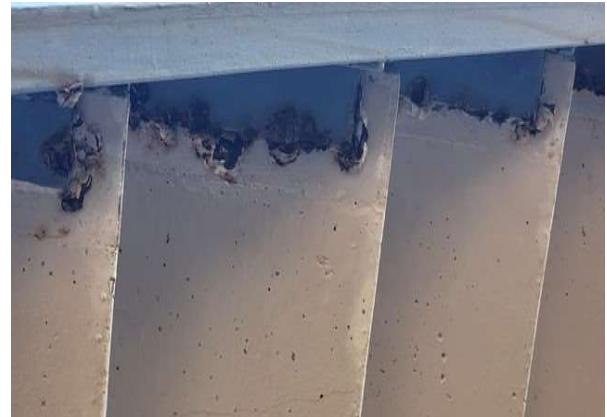
84 Rusted Tread Supports Stairs to 2nd Floor Front Right of Building

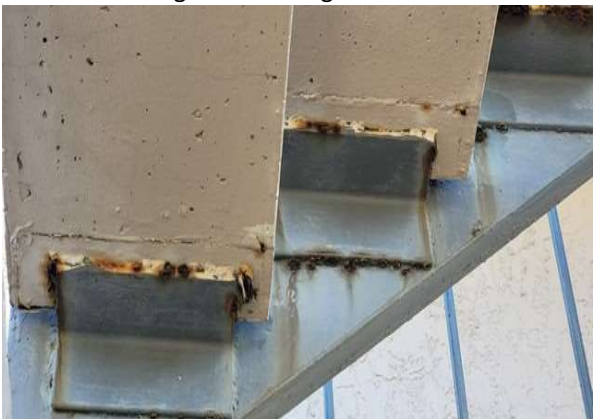
85 Rusted Tread Supports Stairs to 2nd Floor Front Right of Building
