Milestone Inspection – Phase 1

Prepared for the Board of Directors for the
Cordova Green of Largo COA

8681, 8693, 8605 Bardmoor Blvd Seminole, FL 33777

November 6, 2023

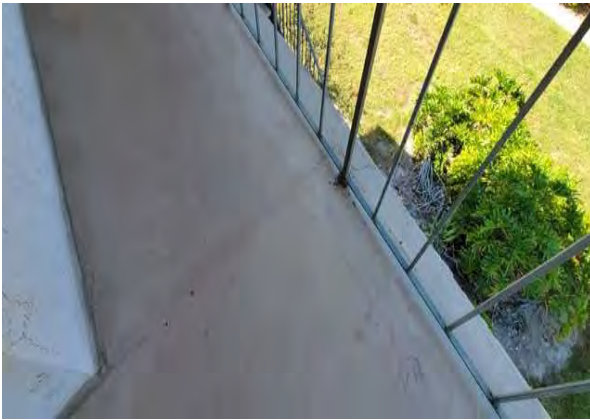
- Building 8681, Level 3 near unit #608
 - Cracked Walkway
- Building 8681, Level 3 near unit #606
 - Cracked Walkway
- Building 8681, Level 3 near unit #604

13 Cracked Walkway 3rd Floor Near Unit 608 Overview

For the Exterior Walls/Breezeways, we recommend that the walkways have a Phase 2 destructive testing performed to determine if the noted areas are structurally compromised or not. During the inspection, we noted multiple concerning areas in the concrete that will require removal to determine the current damage to the reinforcing, as well as develop solutions with repairing these issues as part of a Milestone Phase 2 inspection.

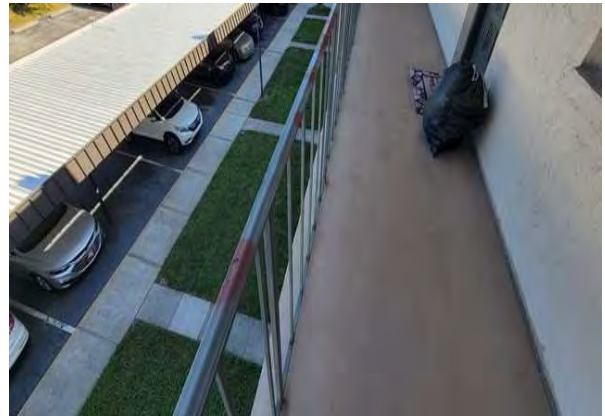
16 3rd Floor Rusted Rail Overview

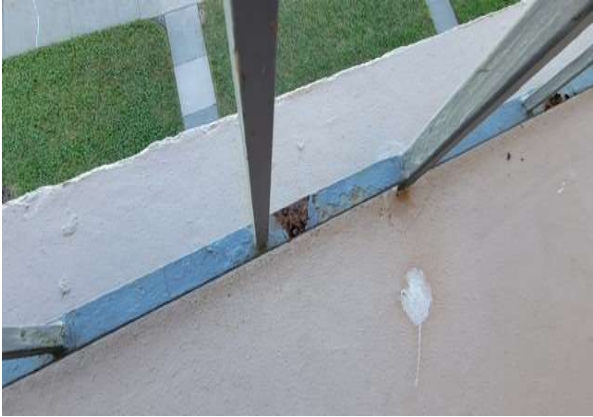
19 3rd Floor Rusted Rail

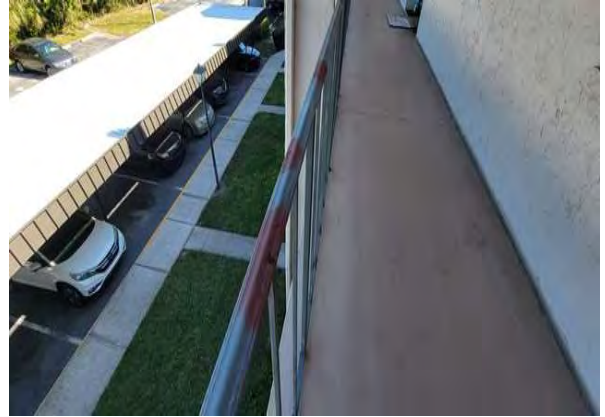
20 3rd Floor Rusted Rail

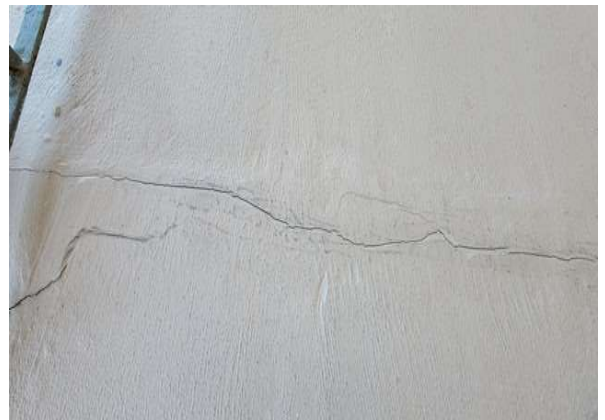
22 Cracked Walkway Near Unit 606

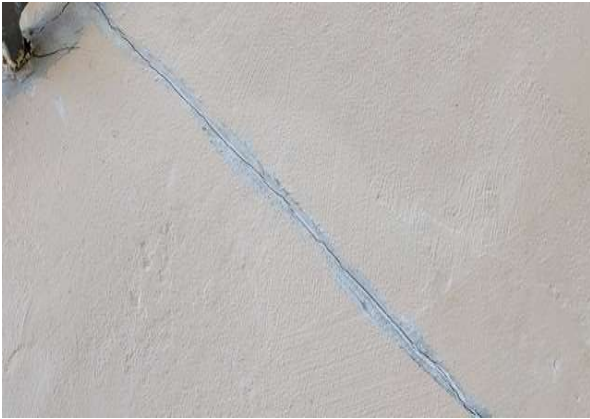
27 Cracked Walkway Near Elevator Lobby 3rd Floor

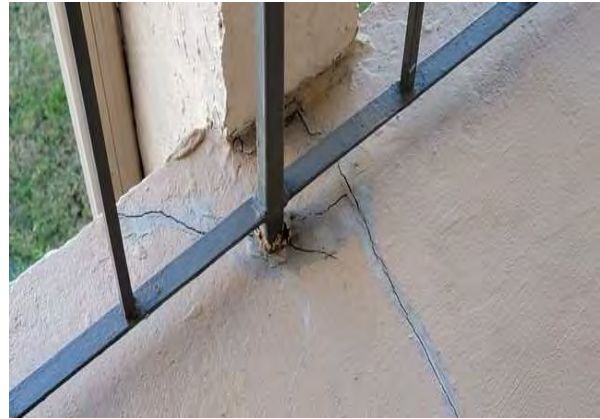
28 Cracked Walkway Near Elevator Lobby 3rd Floor

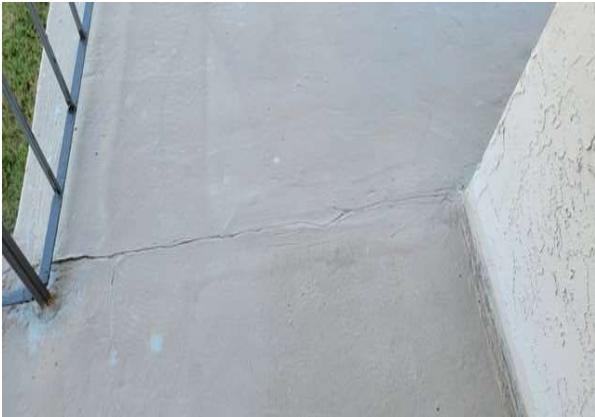
35 Cracked Walkway 2nd Floor Near Right Stairwell Overview

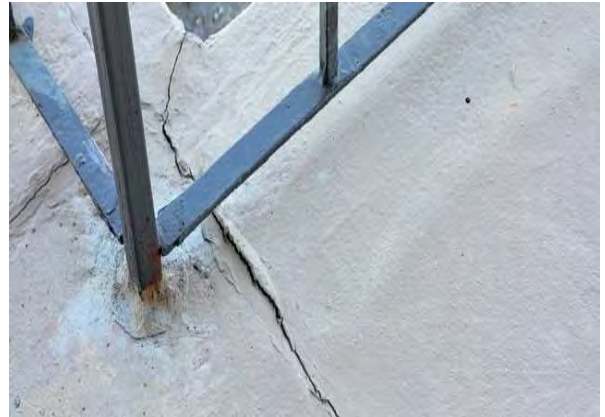
36 Cracked Walkway Near Right Stairwell

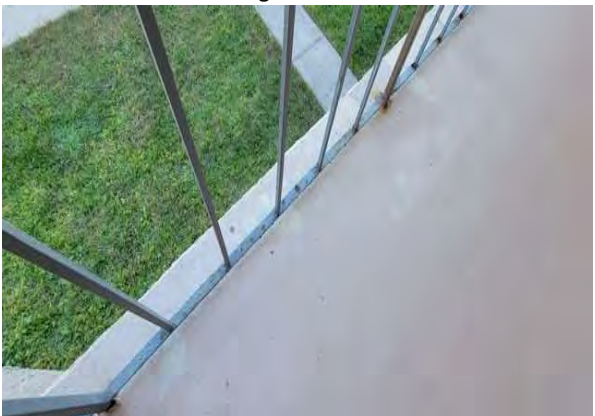
39 Rusty Handrail 2nd Floor Near Elevator Lobby Right Side Overview

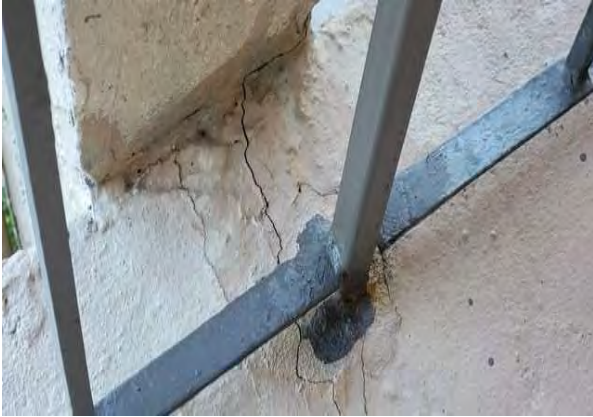
43 Cracked Walkway 2nd Floor Near Unit 504

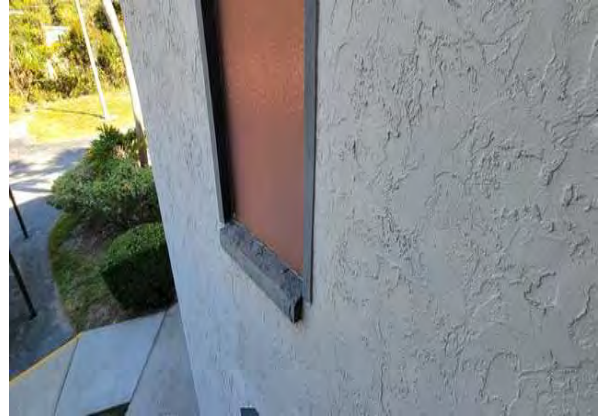
44 Elevator Shaft Decorative Window Sill
Damaged Overview

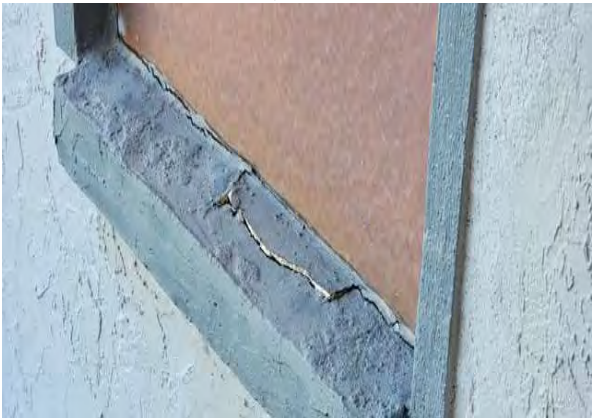
45 Elevator Shaft Decorative Window Sill
Damaged

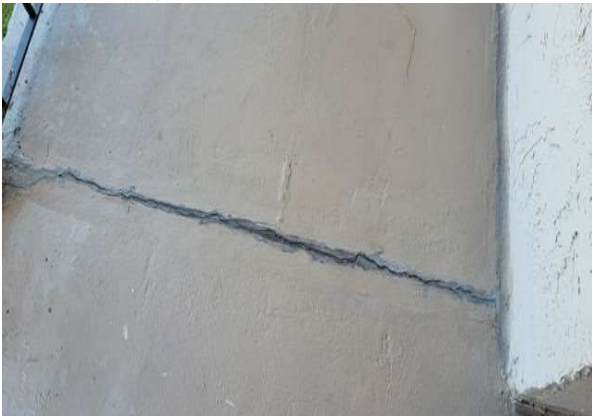
47 Cracked Walkway 2nd Floor Left of Elevator
Lobby

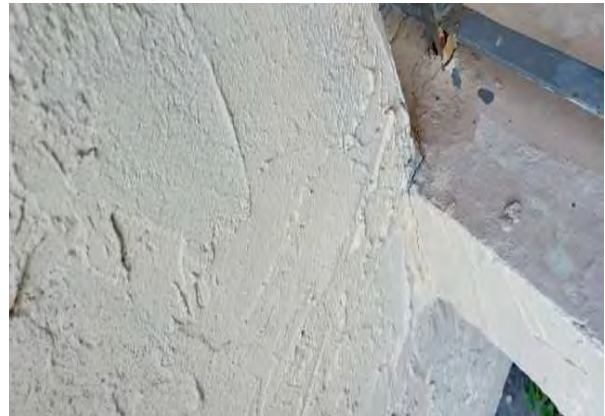
48 Cracked Walkway 2nd Floor Left of Elevator
Lobby

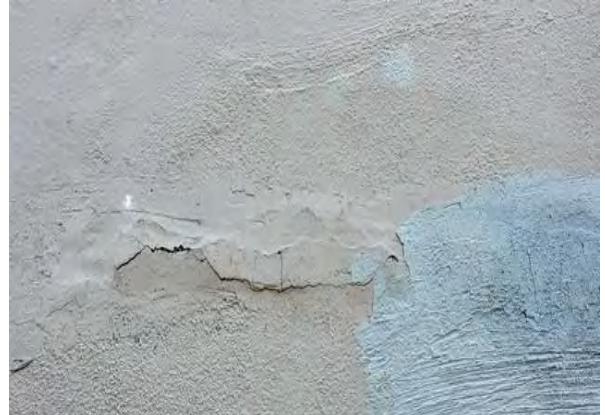
52 Damaged Concrete 2nd Floor Between Units 503 & 504

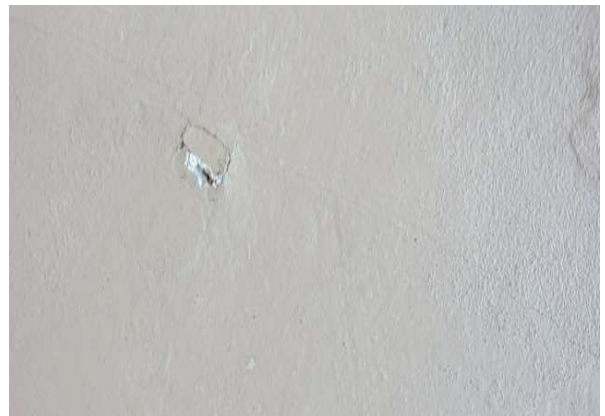
56 Damaged Concrete 2nd Floor Between Units 503 & 504

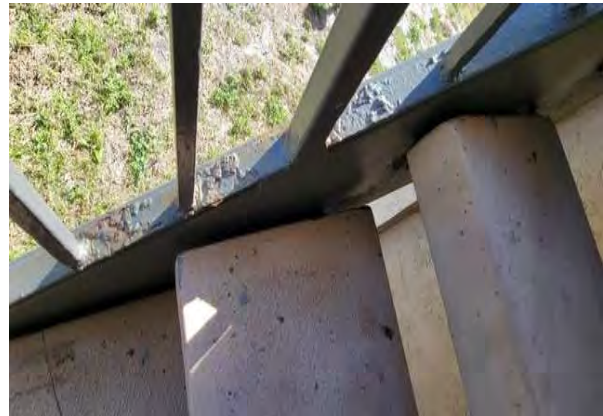
64 Rusted Handrail at Stairwell to 1sr Floor Left Side

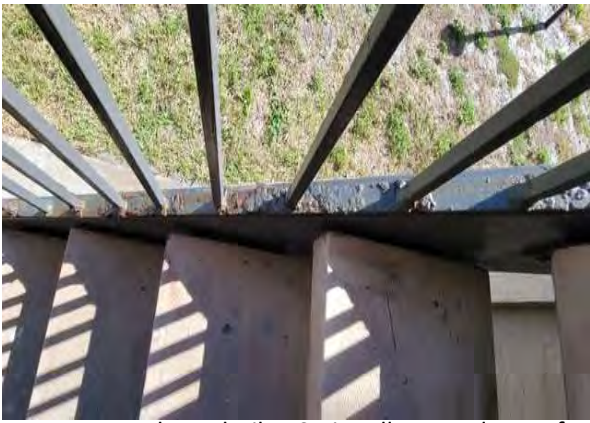
65 Rusted Handrail at Stairwell to 1sr Floor Left Side

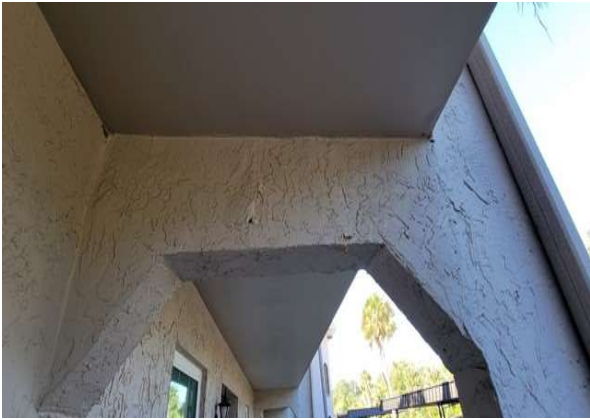
67 Damaged Stucco 1st Floor Near Unit 401 Overview

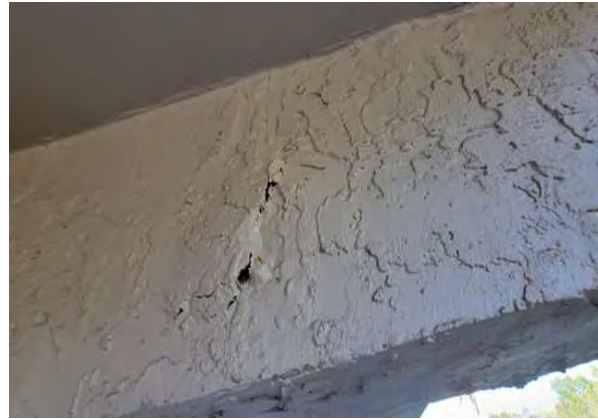
68 Damaged Stucco 1st Floor Near Unit 401

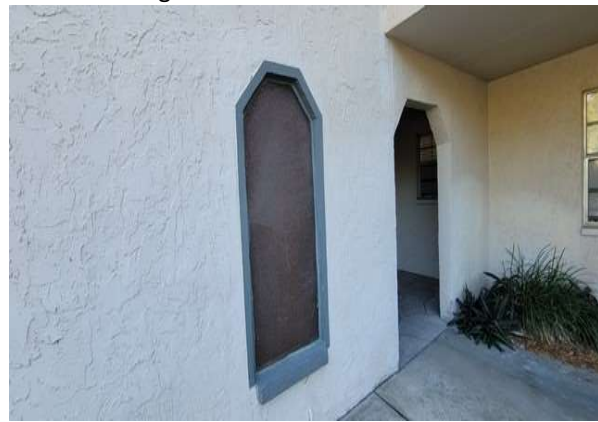
70 Broken Decroitive Window at 1st Floor Lobby Right Side Overview

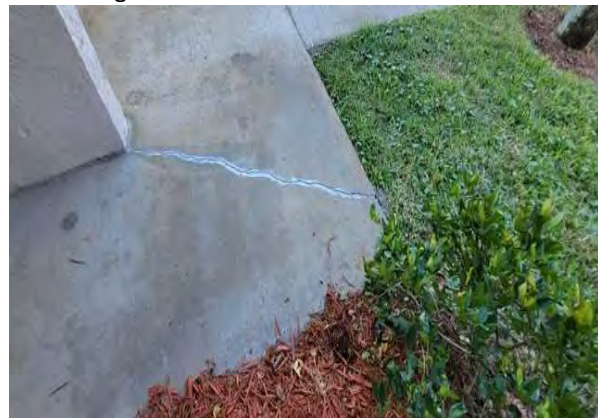
72 Cracked Sidewalk Front Right Corner of Building Overview

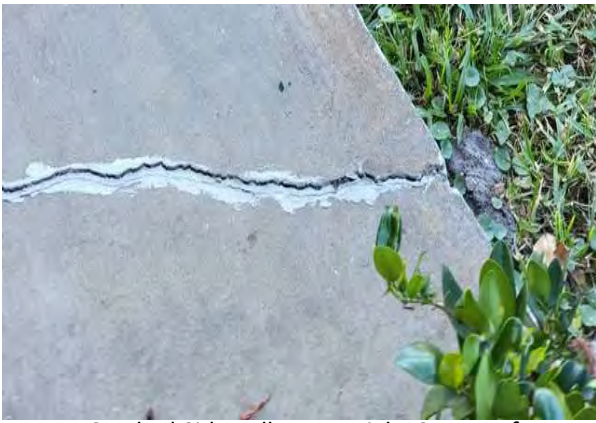
73 Cracked Sidewalk Front Right Corner of Building

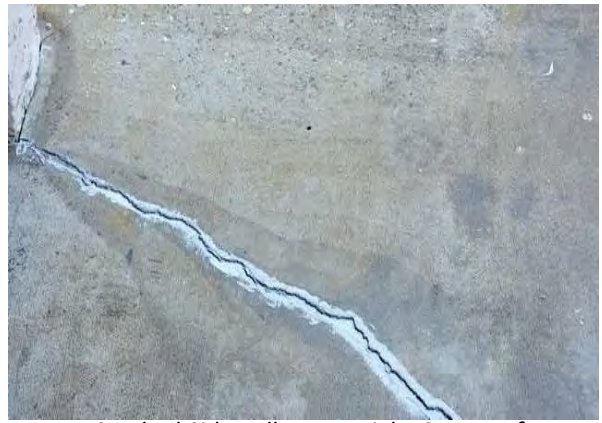
74 Cracked Sidewalk Front Right Corner of Building

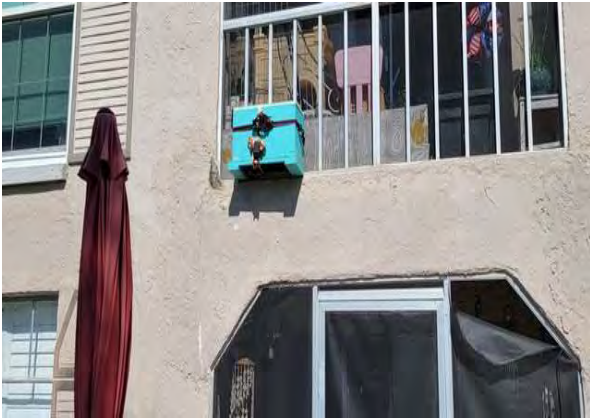
75 Cracked Stucco Rear Wall Between Units 401 & 501 Overview

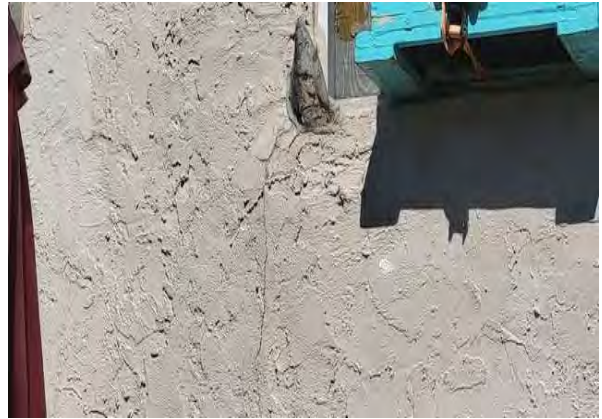
76 Cracked Stucco Rear Wall Between Units 401 & 501

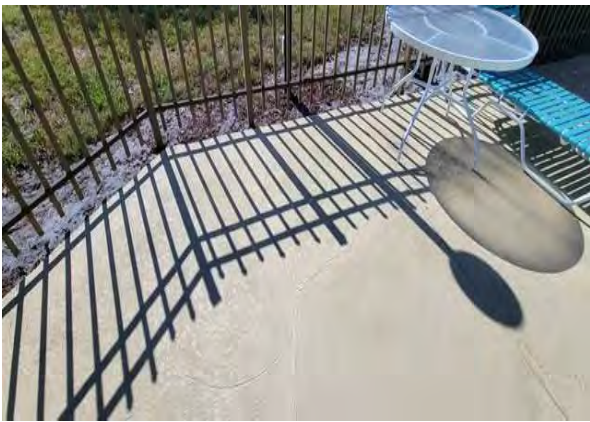
77 Cracked Pool Deck Overview

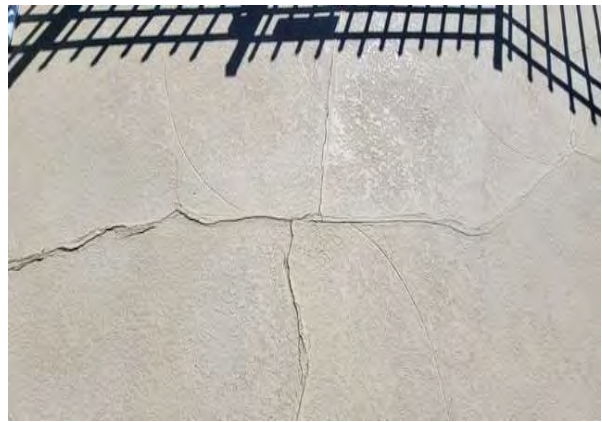
78 Cracked Pool Deck

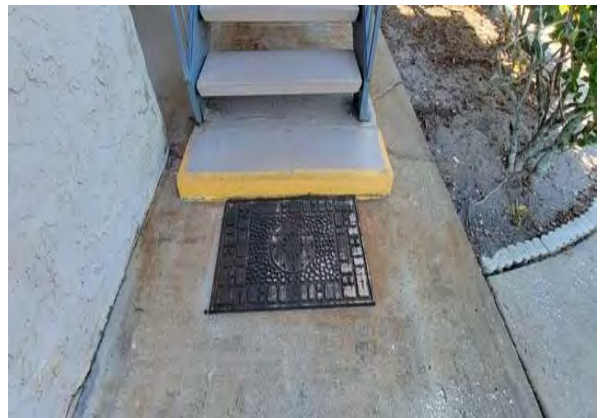
80 Rusted Stair Stringer and Hardware Front Right of Building Overview

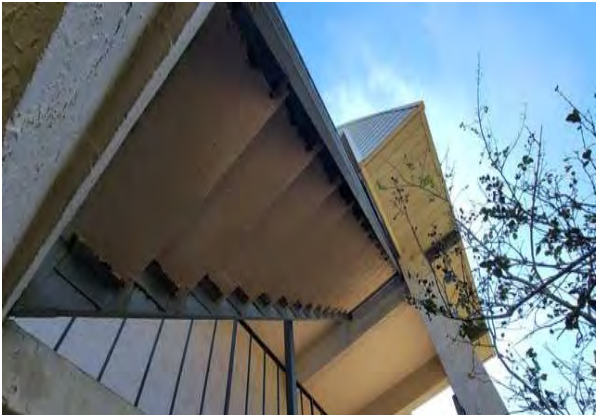
83 Rusted Tread Supports Stairs to 2nd Floor Front Right of Building Overview

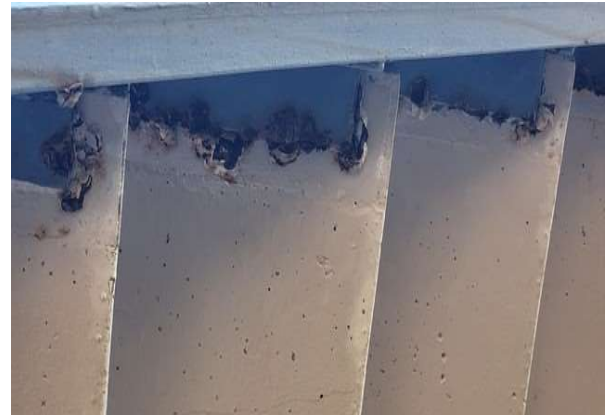
84 Rusted Tread Supports Stairs to 2nd Floor Front Right of Building

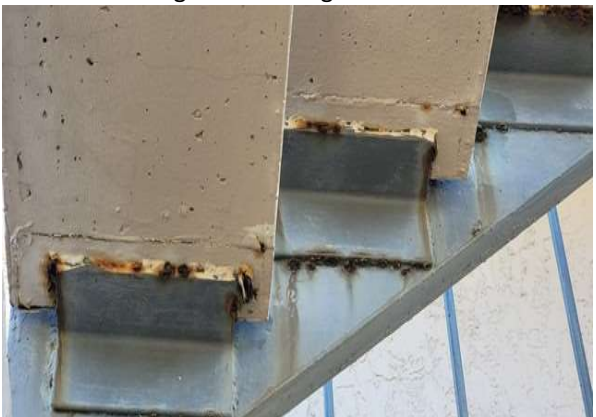
85 Rusted Tread Supports Stairs to 2nd Floor Front Right of Building
