## Reserve Study

Prepared for the Board of Directors for the  
**Cordova Greens of Largo COA**

8681, 8693, 8605 Bardmoor Blvd, Seminole, Florida 33777

November 6, 2023

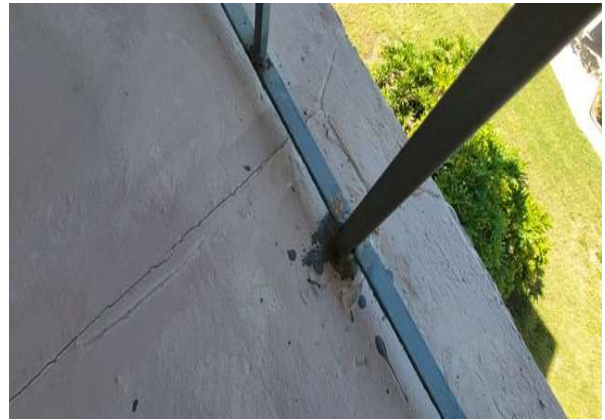
Cracked Walkway 3rd Floor Near Unit 608

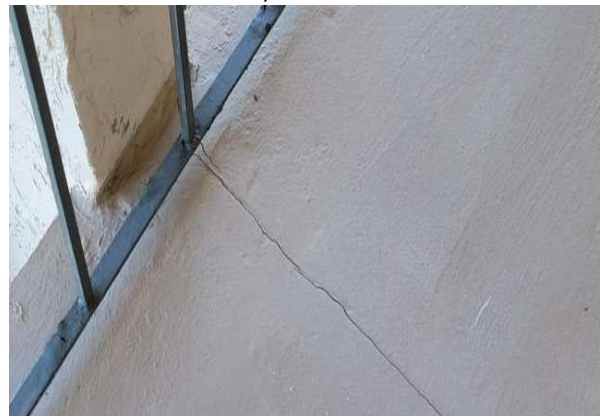
23 Cracked Walkway Near Unit 604 Overview

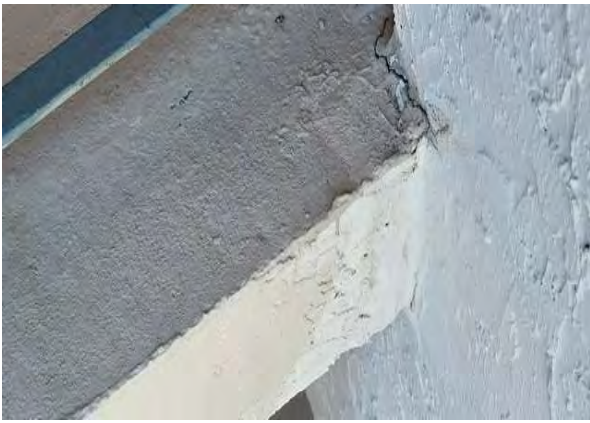
24 Cracked Walkway Near Unit 604

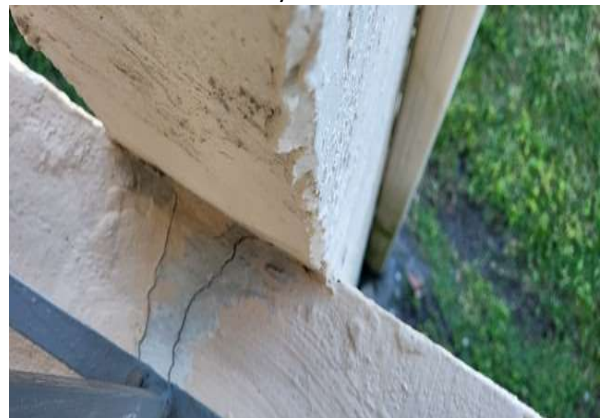
31 Cracked Walkway Near Unit 603

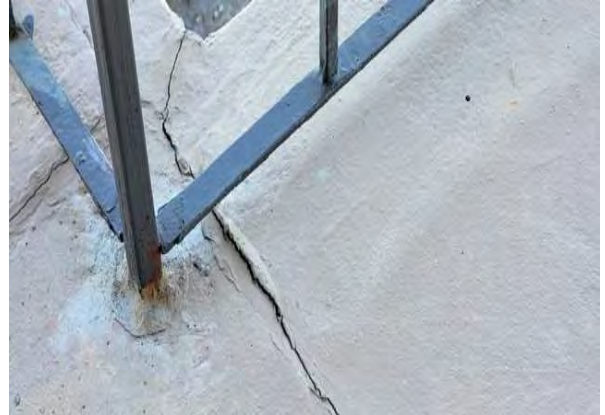
**35** Cracked Walkway 2nd Floor Near Right Stairwell Overview

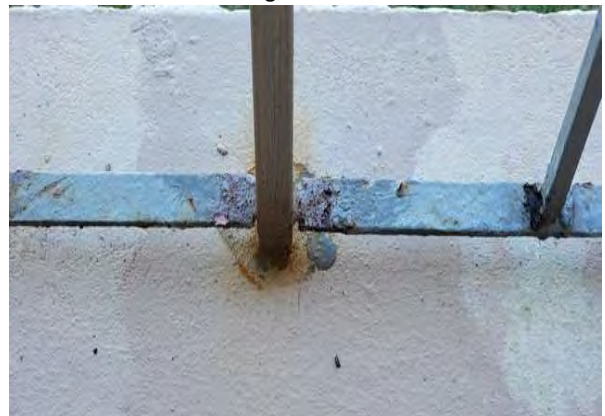
**39** Rusted Handrail 2nd Floor Near Elevator Lobby Right Side Overview

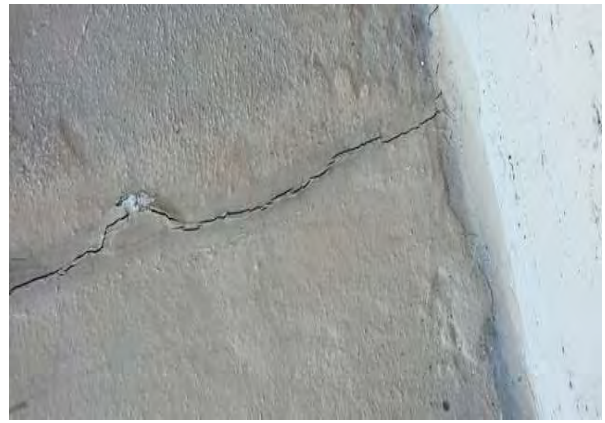
**41** Cracked Walkway 2nd Floor Near Unit 504  
Overview

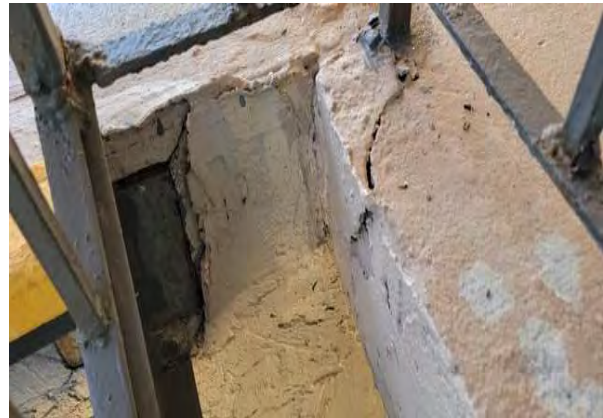
61 Damaged Walkway at Stairwell 2nd Floor Left Side

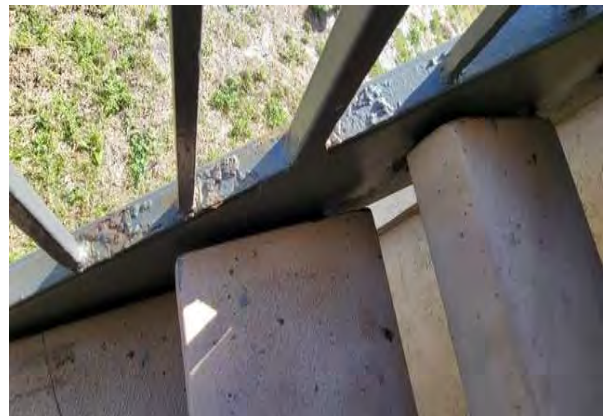
63 Rusted Handrail at Stairwell to 1sr Floor Left Side Overview

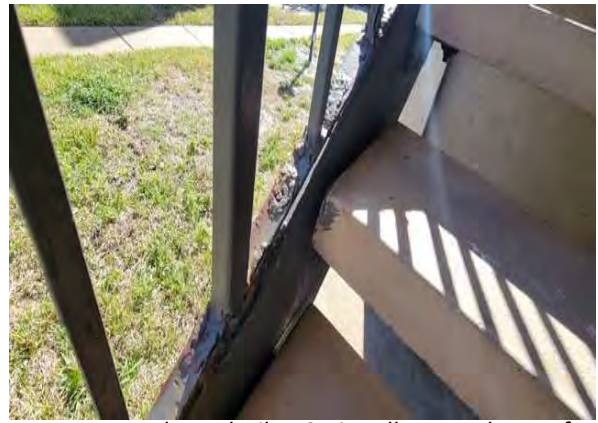
65 Rusted Handrail at Stairwell to 1sr Floor Left Side

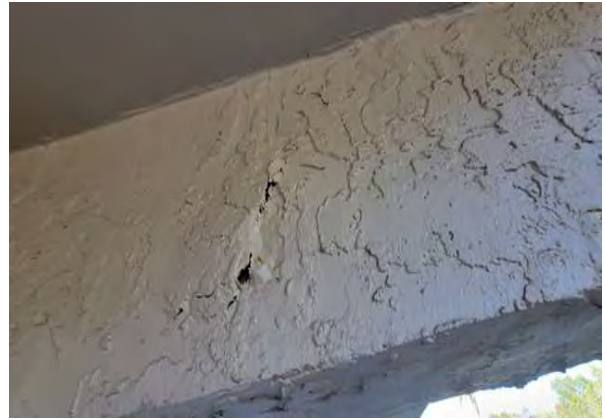
67 Damaged Stucco 1st Floor Near Unit 401 Overview

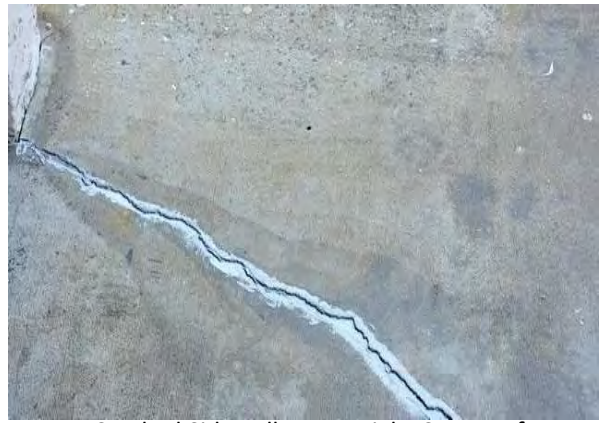
**73** Cracked Sidewalk Front Right Corner of Building

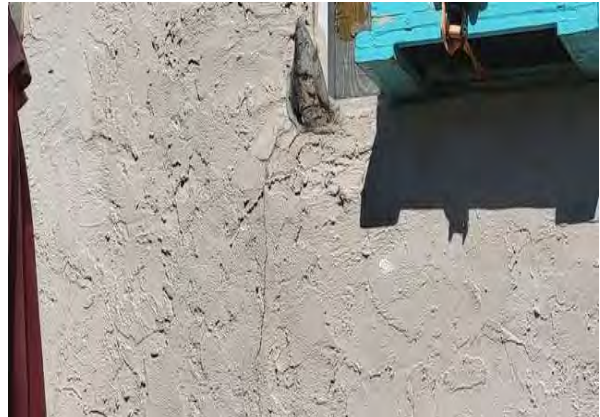
**75** Cracked Stucco Rear Wall Between Units 401 & 501 Overview

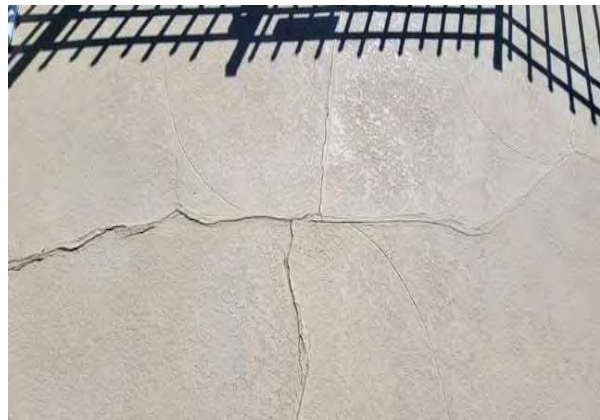
**77** Cracked Pool Deck Overview

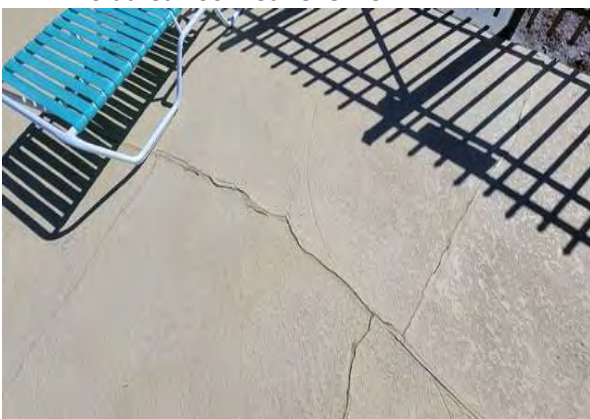
**78** Cracked Pool Deck

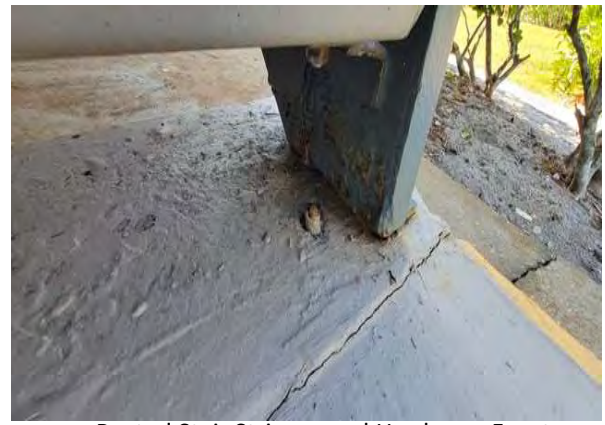
**81** Rusted Stair Stringer and Hardware Front Right of Building

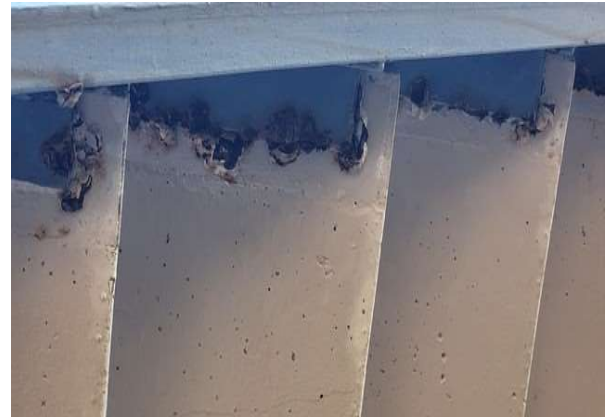
**83** Rusted Tread Supports Stairs to 2nd Floor Front Right of Building Overview
