## **Reserve Study**

## **Cordova Greens of Largo COA**

8681, 8693, 8605 Bardmoor Blvd, Seminole, Florida 33777

**November 6, 2023**

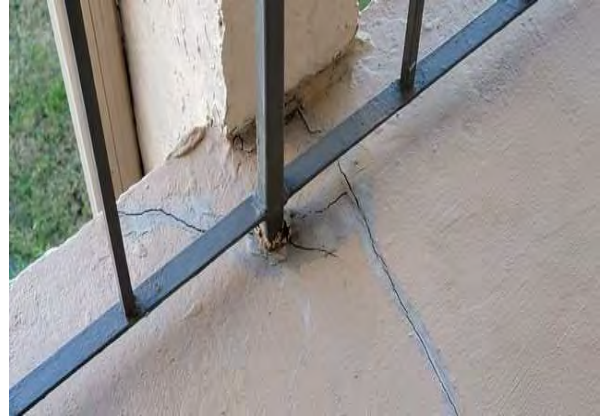
27 Cracked Walkway Near Elevator Lobby 3rd Floor

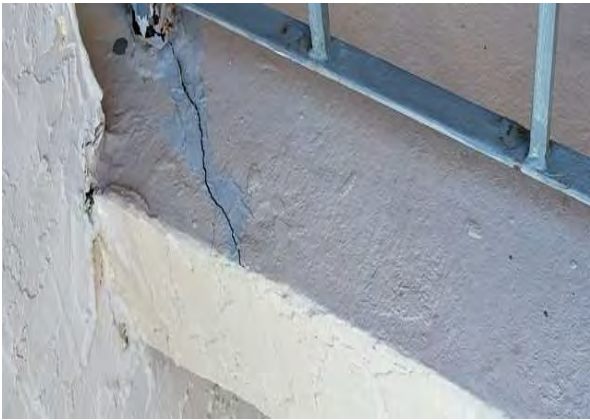
28 Cracked Walkway Near Elevator Lobby 3rd Floor

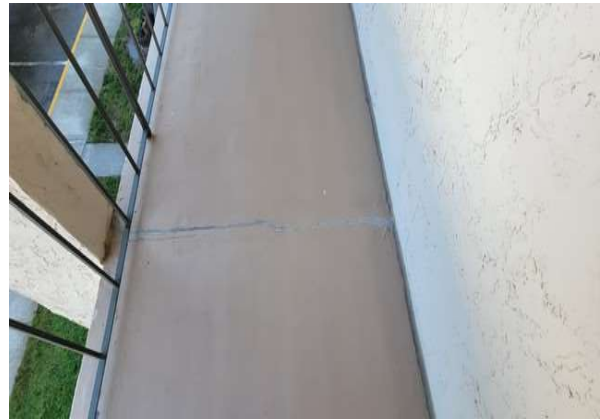
29 Cracked Walkway Near Elevator Lobby 3rd Floor

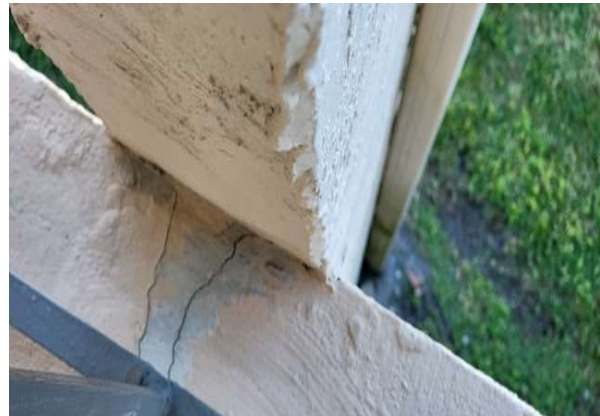
31 Cracked Walkway Near Unit 603

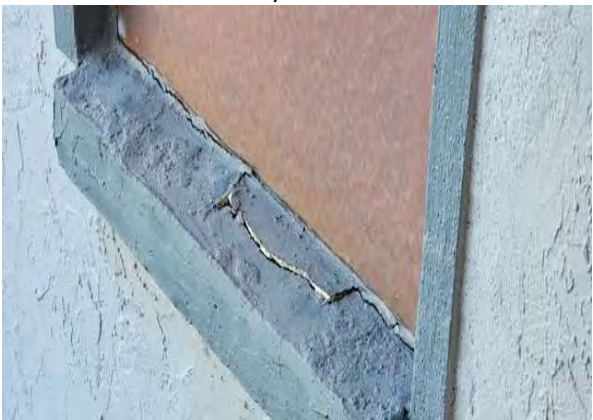
**44** Elevator Shaft Decorative Window Sill  
Damaged Overview

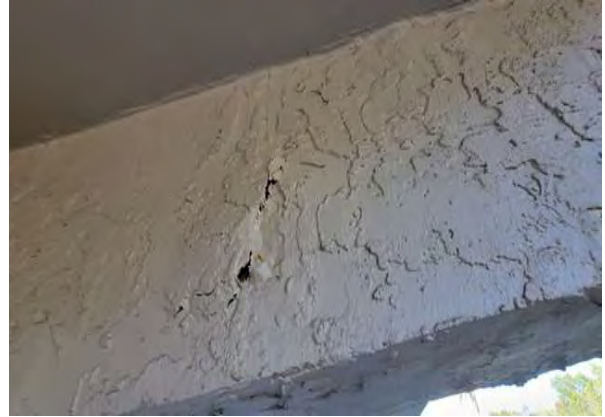
67 Damaged Stucco 1st Floor Near Unit 401 Overview

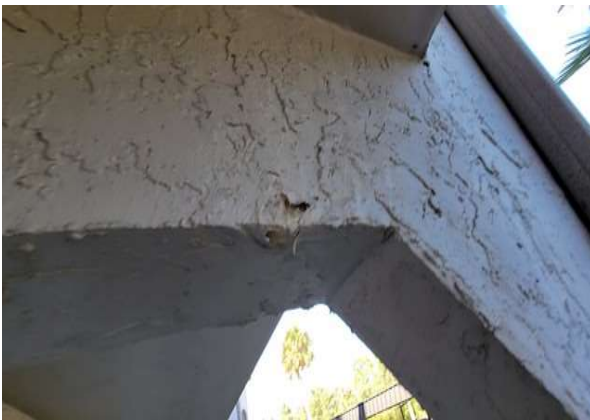
68 Damaged Stucco 1st Floor Near Unit 401
