Milestone Inspection – Phase 1

Prepared for the Board of Directors for the
Cordova Green of Largo COA

8681, 8693, 8605 Bardmoor Blvd Seminole, FL 33777

November 6, 2023

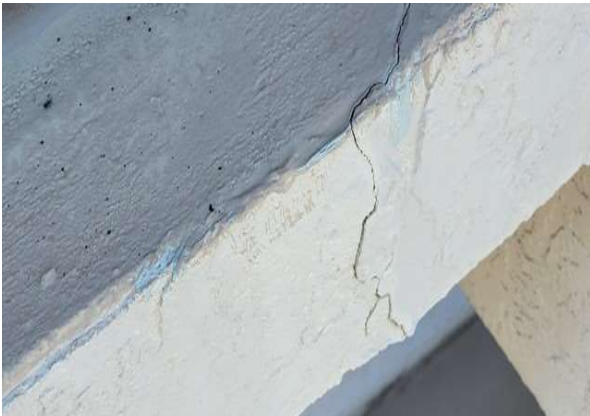
- Building 8681, Level 3 near unit #608
 - Cracked Walkway
- Building 8681, Level 3 near unit #606
 - Cracked Walkway
- Building 8681, Level 3 near unit #604

15 Cracked Walkway 3rd Floor Near Unit 608

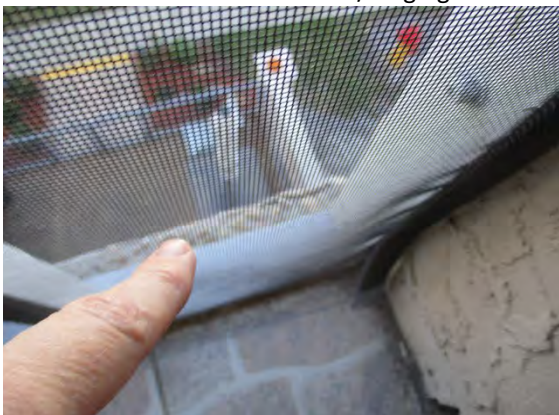
6 Unit 207 Stucco Cracked/Bulging

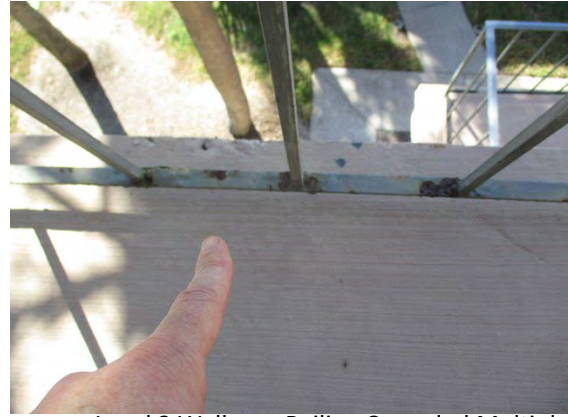
9

Level 3 Walkway Railing Corroded Multiple Areas

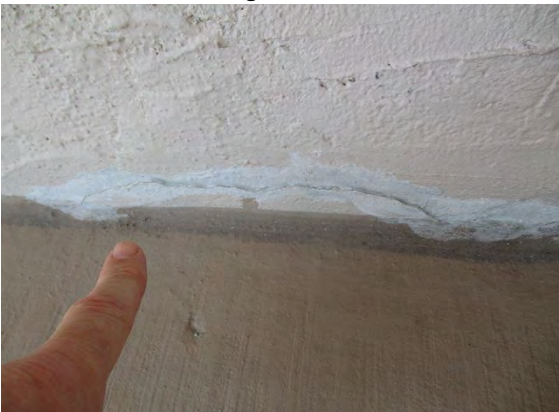
14

Level 3 Prior Repair For Separation at Walkway to Building Connection (Leaning)

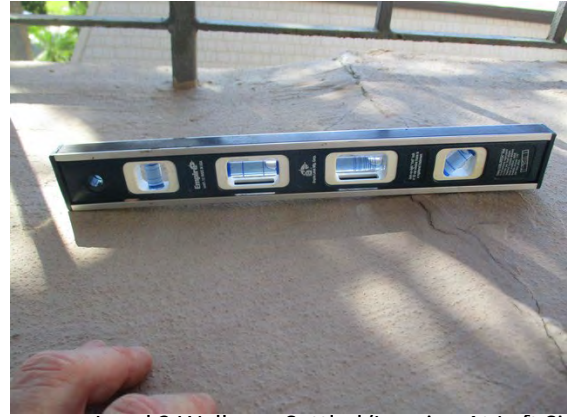
17 Level 3 Walkway Settled/Leaning At Left Side of Building

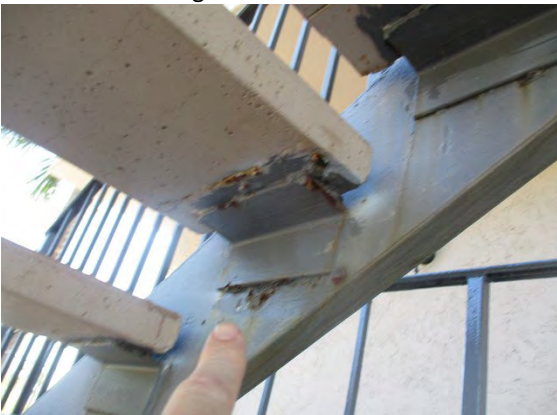
20 Right & Left Stairwell L-brackets For Stair Treads Corroded

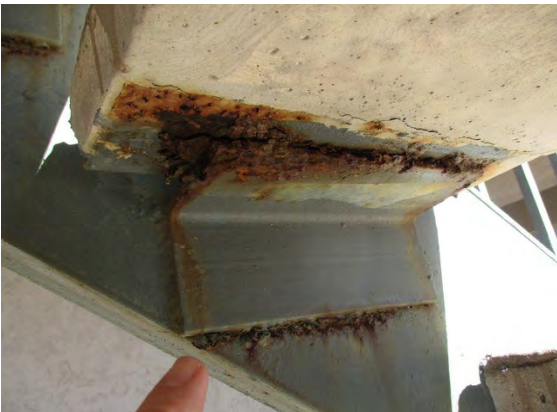
22 Right & Left Stairwell L-brackets For Stair Treads Corroded

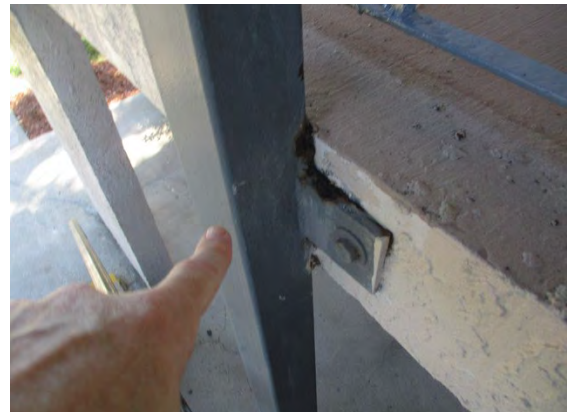
23 Right & Left Stairwell L-brackets For Stair Treads Corroded

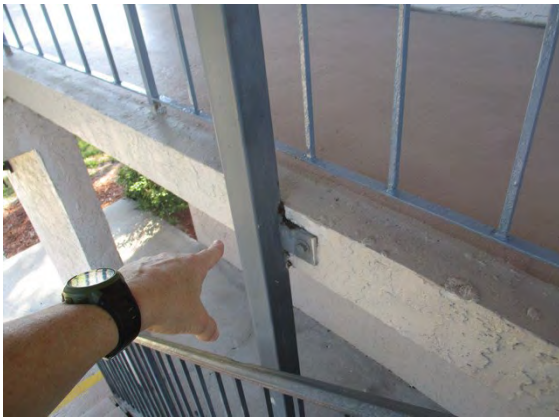
24 Right Stairwell Support Column Corroded

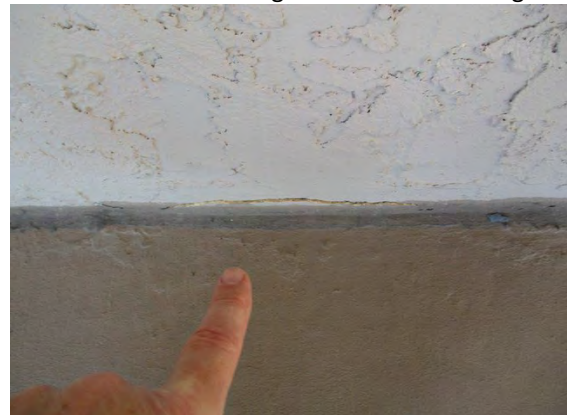
29 Level 2 Prior Repair For Separation at Walkway to Building Connection (Leaning)

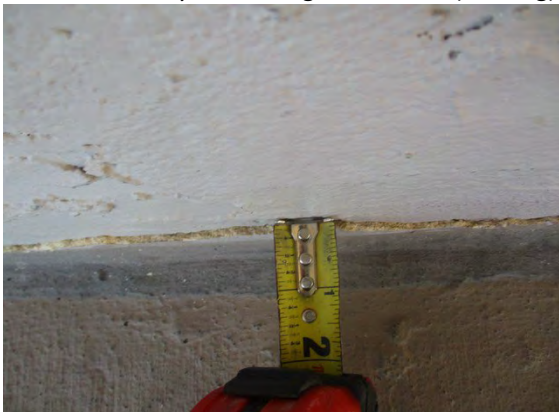
30 Level 2 Prior Repair For Separation at Walkway to Building Connection (Leaning)

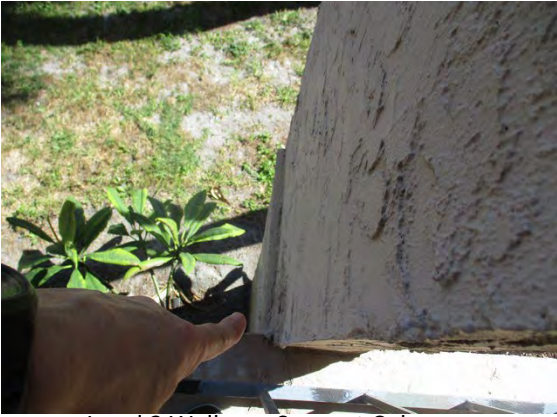
32 Level 2 Walkway Support Column Shifted/Displaced Left of #202

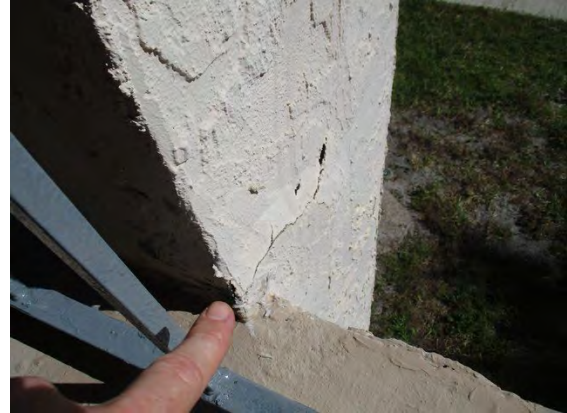
35 Level 2 Walkway Support Column Stucco
Cracked/Bulging Right of #206

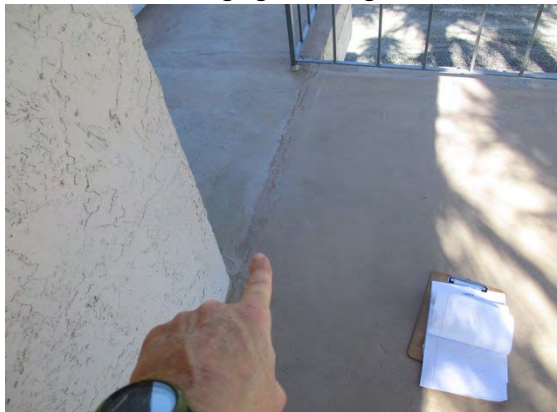
38 Level 2 Walkway shifted/Displaced/Leaning
Right Side of Building

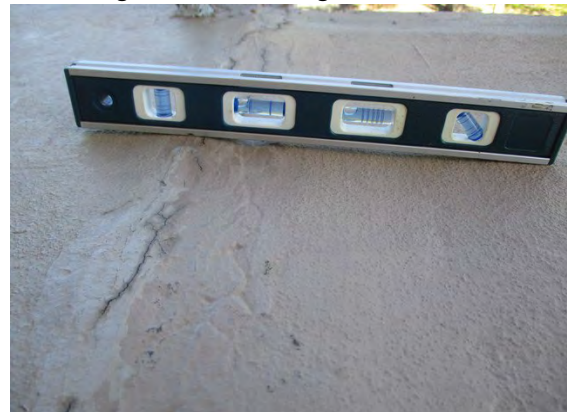
39 Level 2 Walkway Shifted/Displaced/Leaning
Right Side of Building

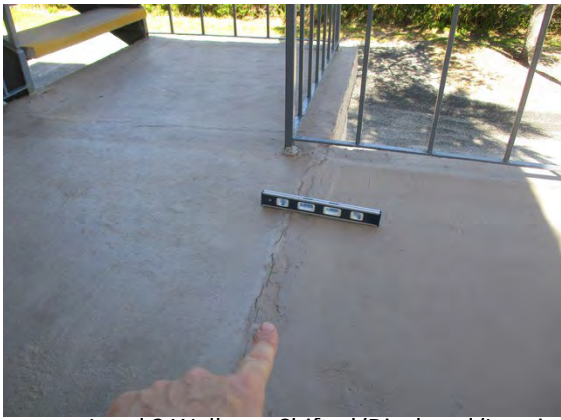
40 Level 2 Walkway Shifted/Displaced/Leaning
Right Side of Building

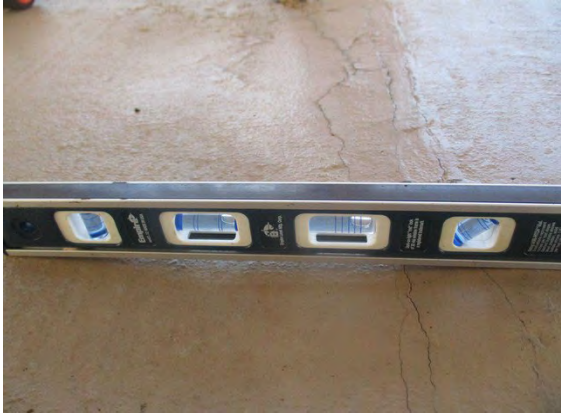
42 Level 2 Walkway Shifted/Displaced/Leaning
Left Side of Building

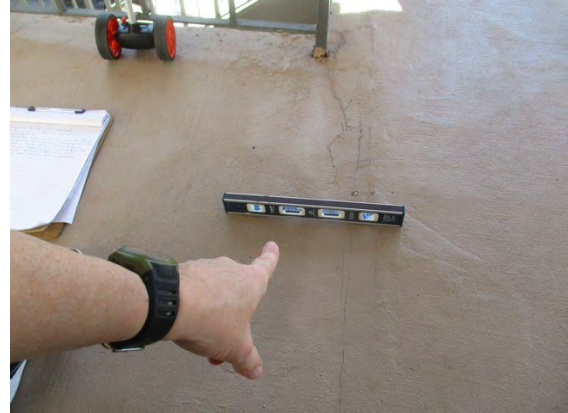
43 Level 2 Walkway Shifted/Displaced/Leaning
Left Side of Building

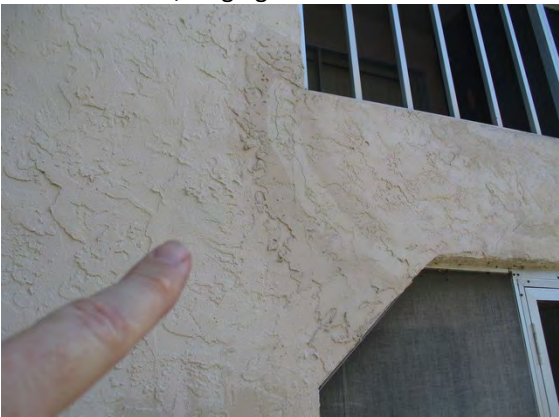
52 Ground Floor Rear Entry Stucco Cracked & Bulging
