Milestone Inspection – Phase 1

Prepared for the Board of Directors for the
Cordova Green of Largo COA

8681, 8693, 8605 Bardmoor Blvd Seminole, FL 33777

November 6, 2023

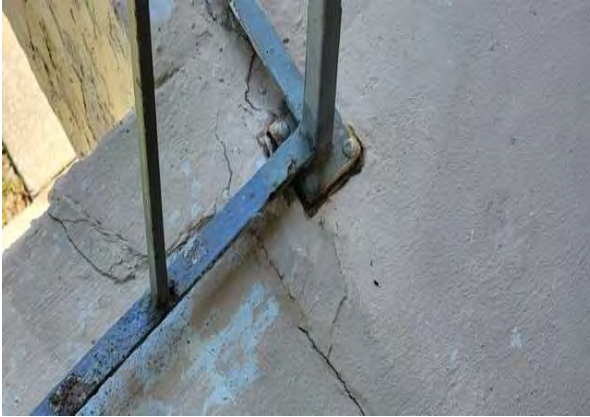
- Damaged Concrete at Walks
- Building 8681, Level 2 near left side stairwell
 - Cracked Walkway
- Building 8681, Level 2 near left side stairwell
 - Damaged Walkway

59 Cracked Walkway 2nd Floor Near Left Stairwell

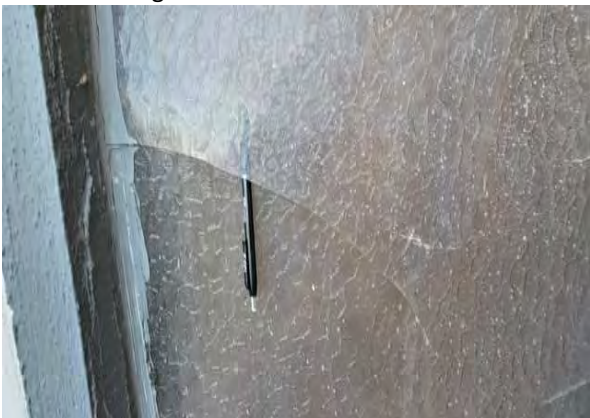
71 Broken Decroitive Window at 1st Floor Lobby Right Side

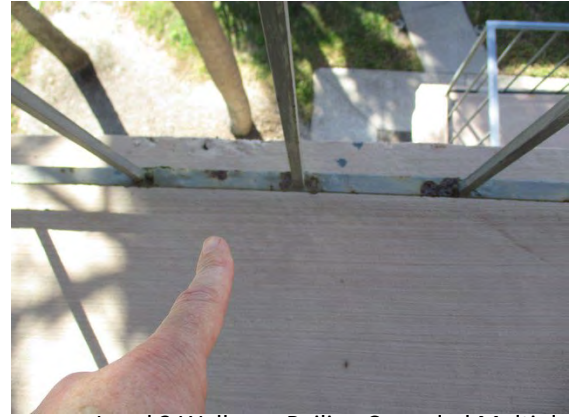
10

Level 3 Walkway Railing Corroded Multiple Areas

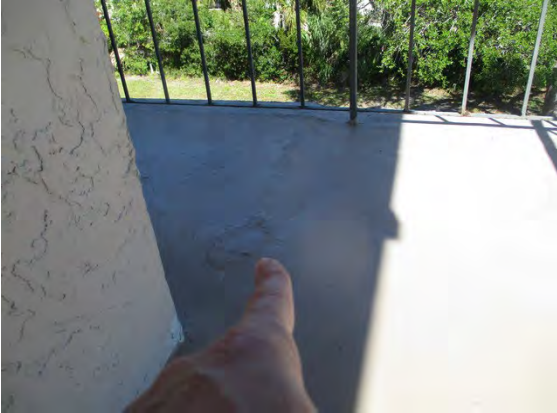
11

Level 3 Walkway Settled/Leaning At Right Side of Building

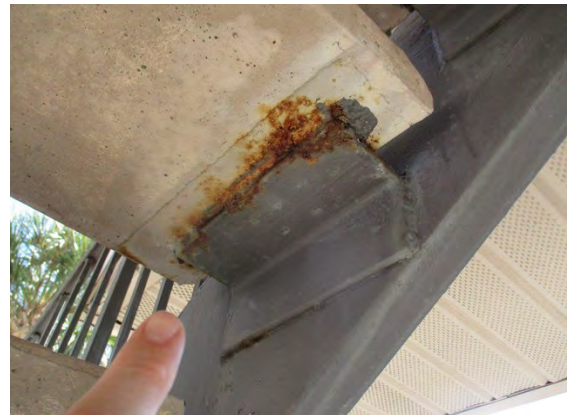
21 Right & Left Stairwell L-brackets For Stair Treads Corroded

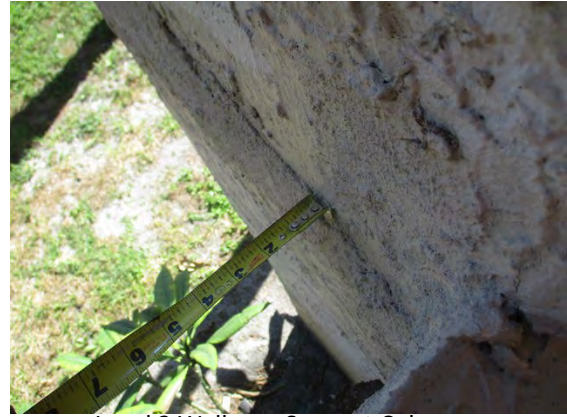
33 Level 2 Walkway Support Column
Shifted/Displaced Left of #202

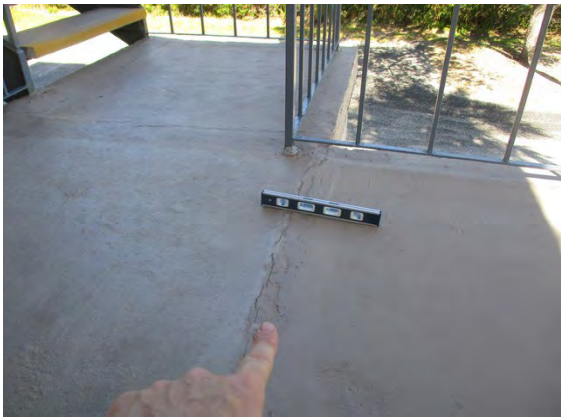
40 Level 2 Walkway Shifted/Displaced/Leaning
Right Side of Building

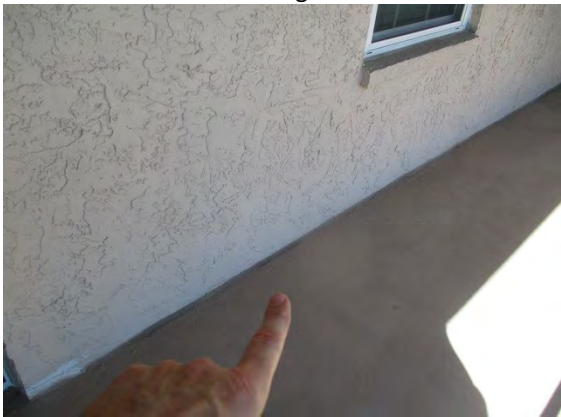
44 Level 2 Walkway Shifted/Displaced/Leaning
Left Side of Building

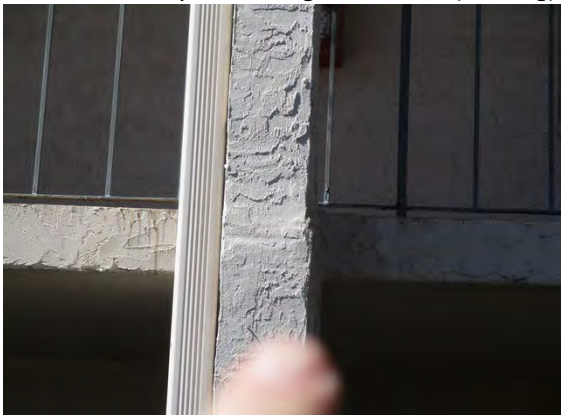
46 Level 2 Walkway Support Column
Shifted/Displaced Between 101 & 102

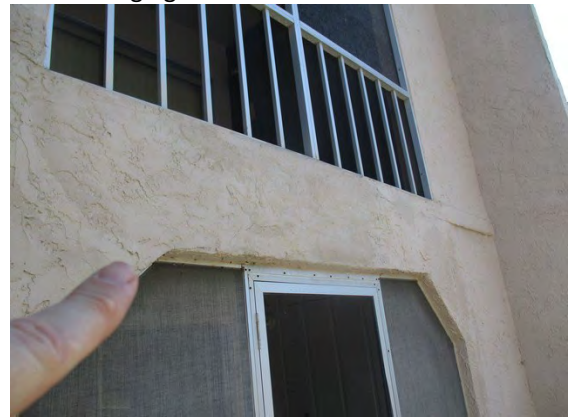
54 Ground Floor Rear Entry Stucco Cracked & Bulging
