## Reserve Study

Prepared for the Board of Directors for the  
**Cordova Greens of Largo COA**

8681, 8693, 8605 Bardmoor Blvd, Seminole, Florida 33777

November 6, 2023

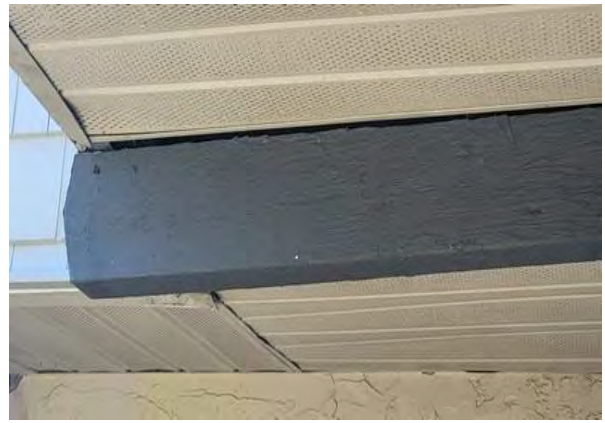
**34** Sagging Support Member Near Left Stairwell

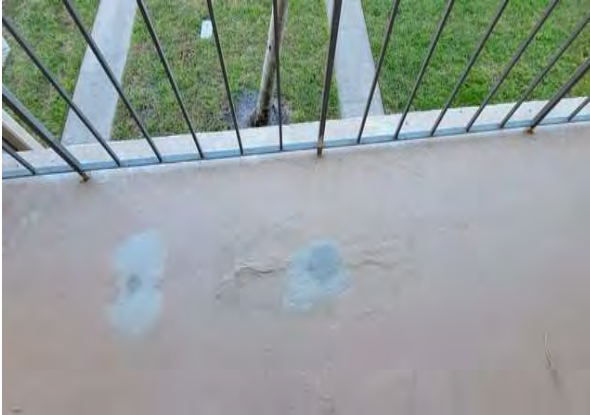
**51** Damaged Concrete 2nd Floor Between Units 503 & 504 Overview

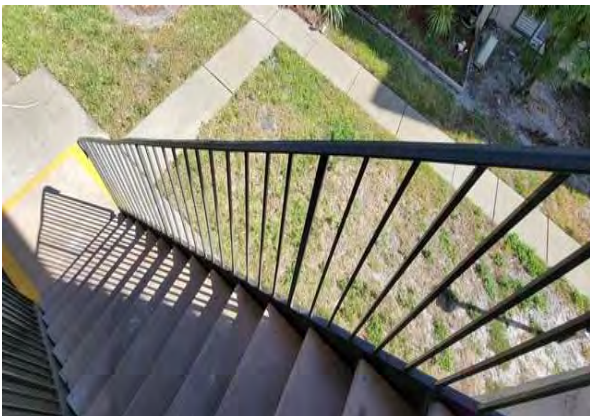
63 Rusted Handrail at Stairwell to 1sr Floor Left Side Overview

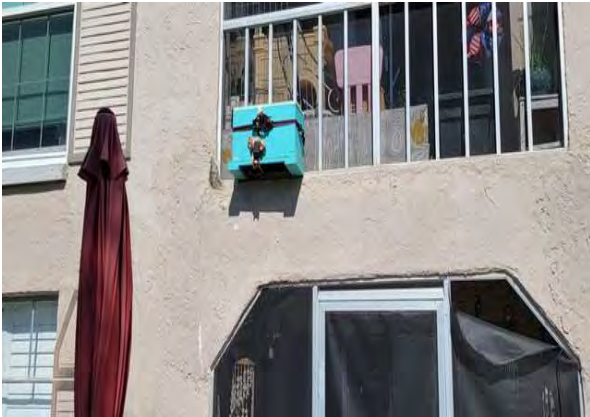
**75** Cracked Stucco Rear Wall Between Units 401 & 501 Overview

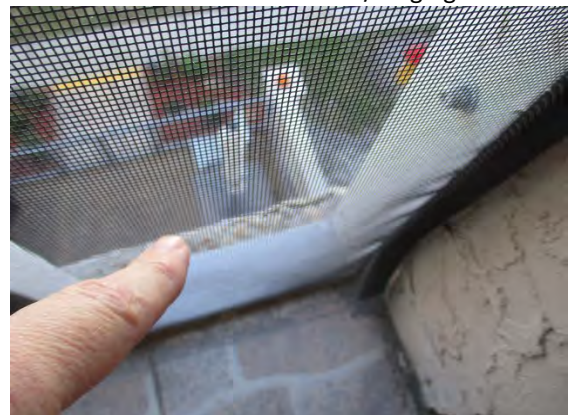
8 Unit 308 Stucco Cracked/Bulging

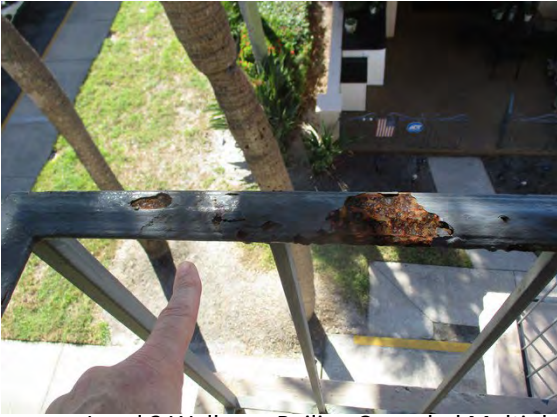
9

Level 3 Walkway Railing Corroded Multiple Areas

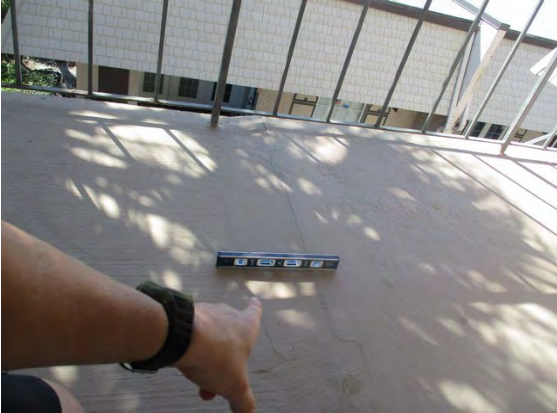
19

Level 3 Walkway Settled/Leaning At Left Side of Building

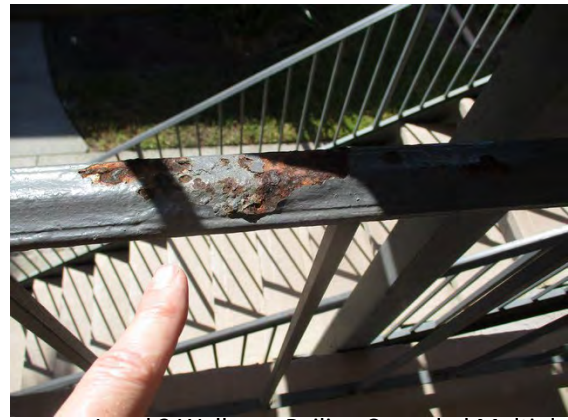
26 Level 2 Walkway Railing Corroded Multiple Areas

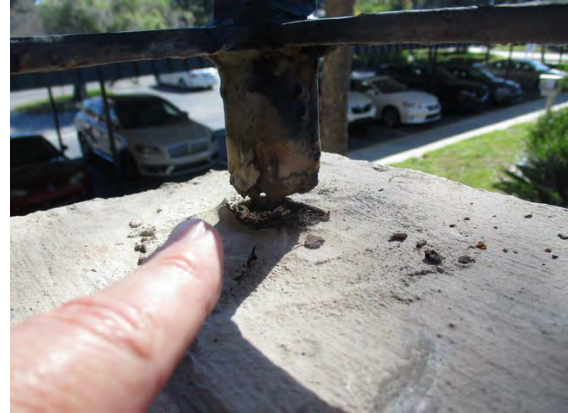
28 Level 2 Walkway Railing Corner Support Post Corroded Through Left Side of Building

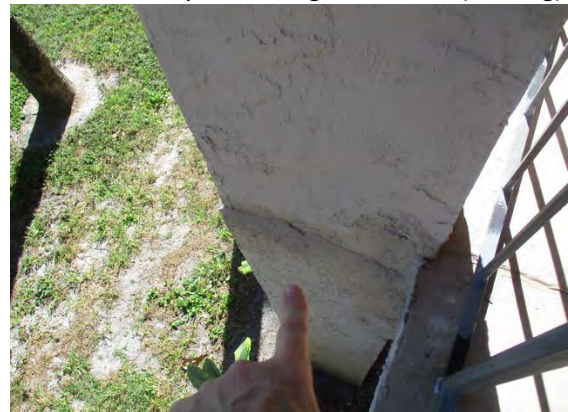
32 Level 2 Walkway Support Column Shifted/Displaced Left of #202

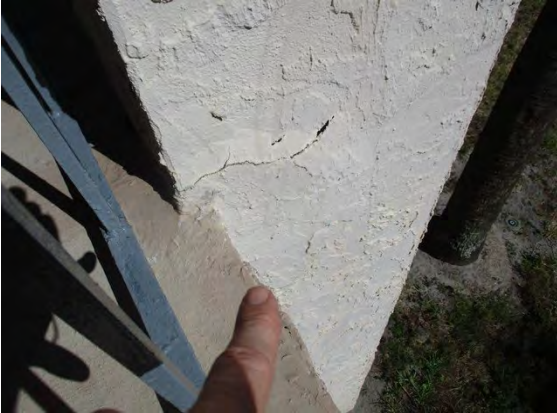
**35** Level 2 Walkway Support Column Stucco  
Cracked/Bulging Right of #206

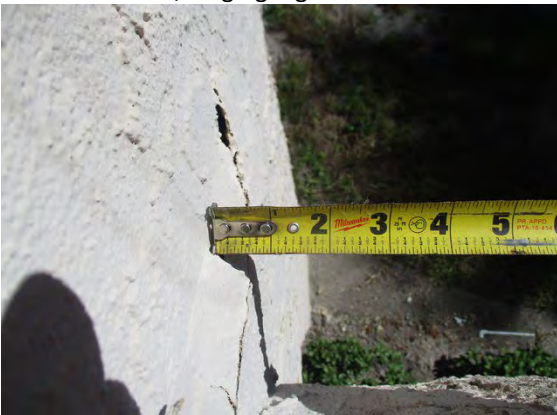
**37** Level 2 Walkway Support Column Stucco  
Cracked/Bulging ~3/4" Right of #206

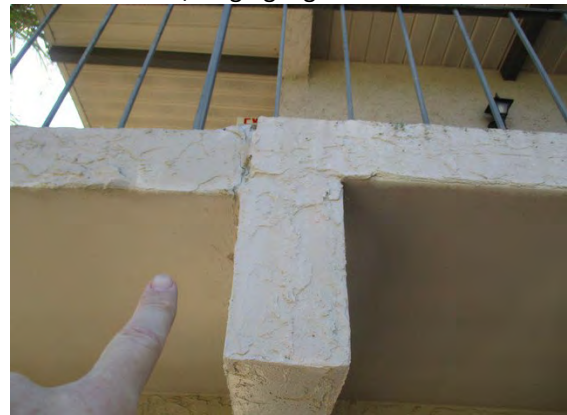
**38** Level 2 Walkway shifted/Displaced/Leaning  
Right Side of Building

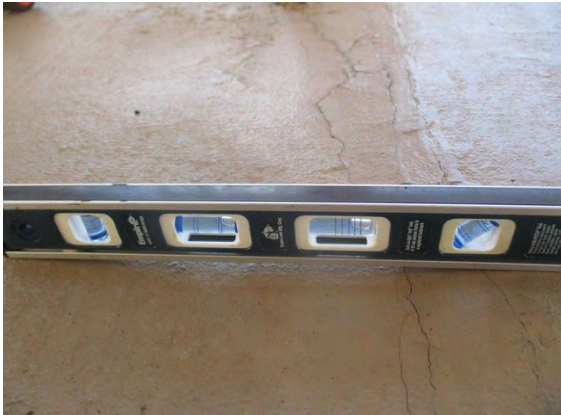
**43** Level 2 Walkway Shifted/Displaced/Leaning  
Left Side of Building

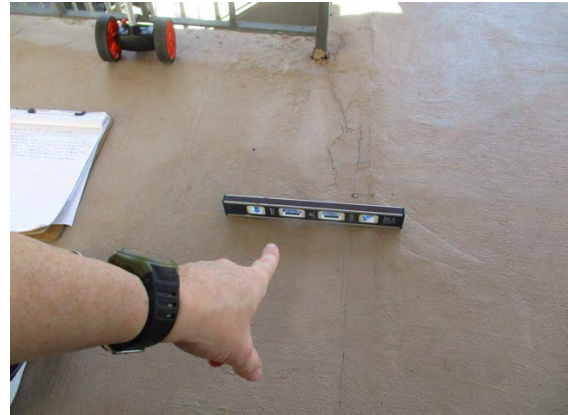
**44** Level 2 Walkway Shifted/Displaced/Leaning  
Left Side of Building

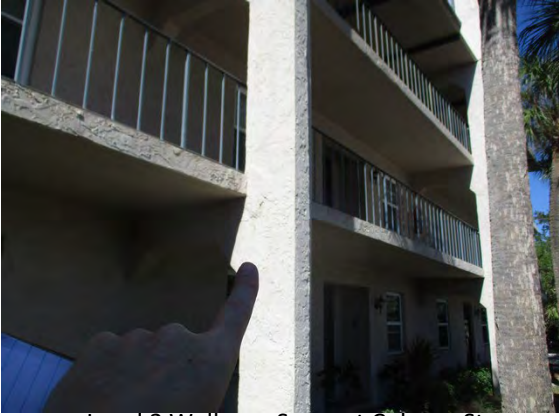
50 Level 2 Walkway Support Column Stucco Cracked/Bulging Between 106 & 107

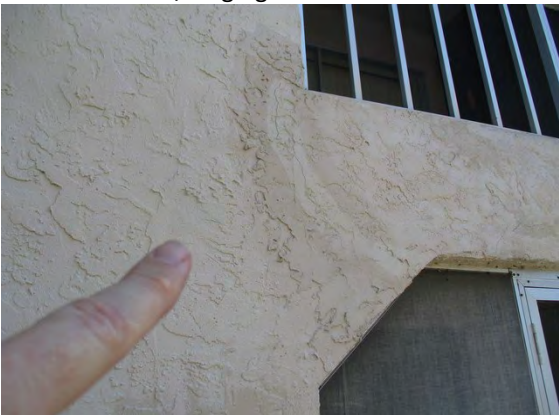
52 Ground Floor Rear Entry Stucco Cracked & Bulging

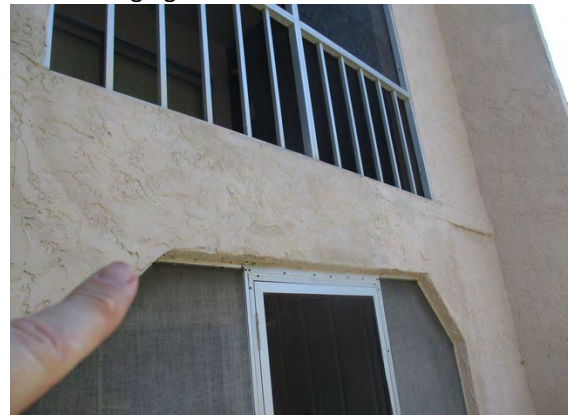
53 Ground Floor Rear Entry Stucco Cracked & Bulging
