## **Reserve Study**

## **Cordova Greens of Largo COA**

8681, 8693, 8605 Bardmoor Blvd, Seminole, Florida 33777

**November 6, 2023**

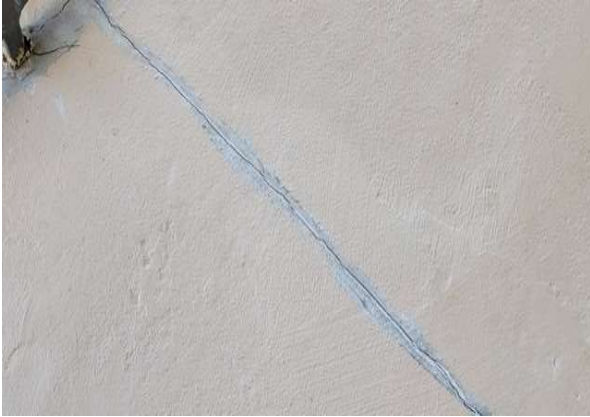
27 Cracked Walkway Near Elevator Lobby 3rd Floor

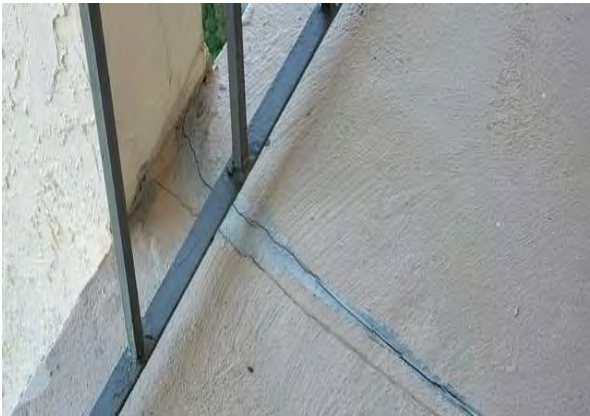
31 Cracked Walkway Near Unit 603

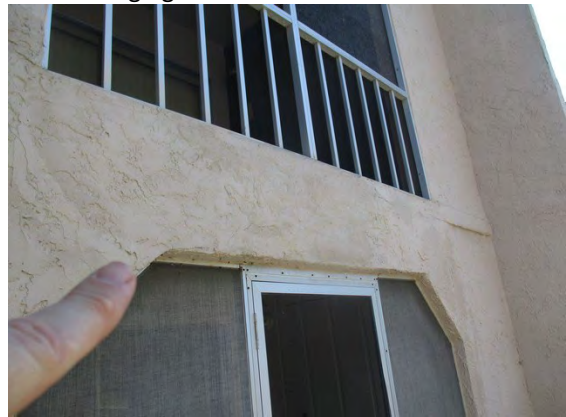
53 Ground Floor Rear Entry Stucco Cracked & Bulging

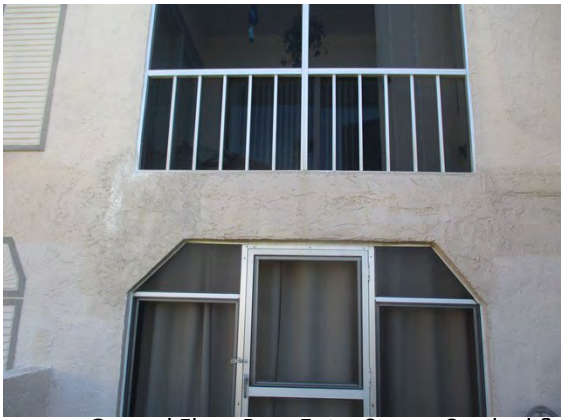
56 Ground Floor Rear Entry Stucco Cracked & Bulging
