Milestone Inspection – Phase 1

Prepared for the Board of Directors for the
Cordova Green of Largo COA

8681, 8693, 8605 Bardmoor Blvd Seminole, FL 33777

November 6, 2023

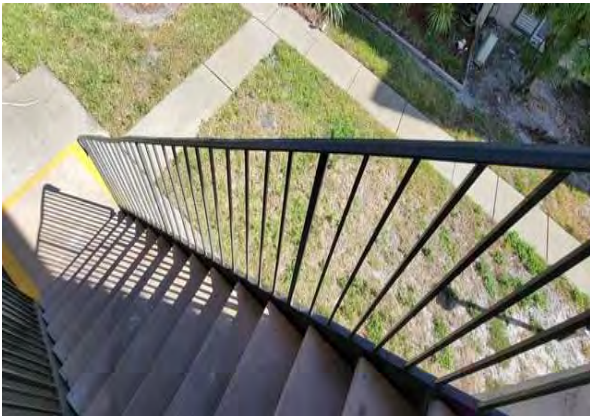
63 Rusted Handrail at Stairwell to 1sr Floor Left Side Overview

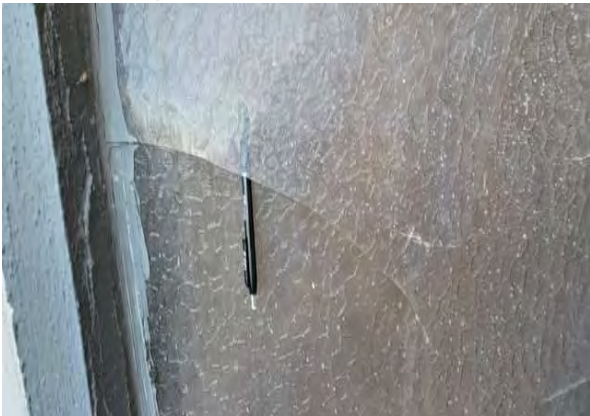
71 Broken Decroitive Window at 1st Floor Lobby Right Side

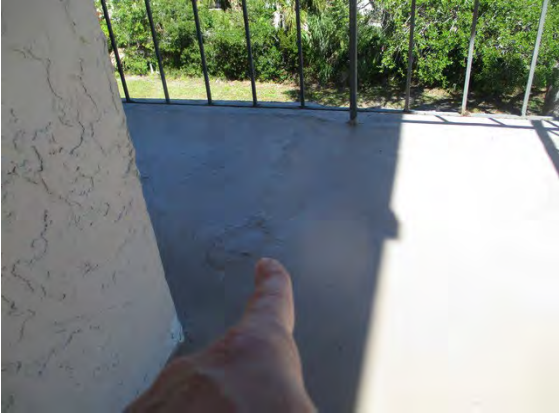
10

Level 3 Walkway Railing Corroded Multiple Areas

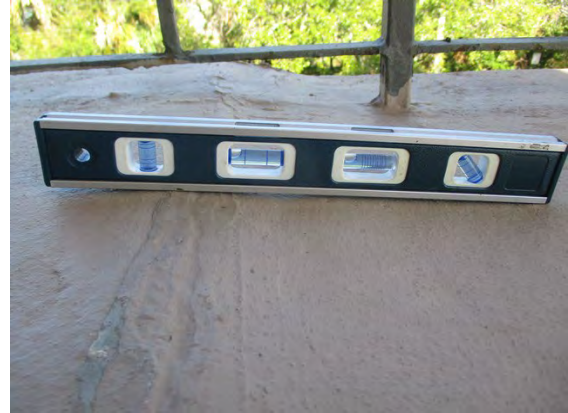
11

Level 3 Walkway Settled/Leaning At Right Side of Building

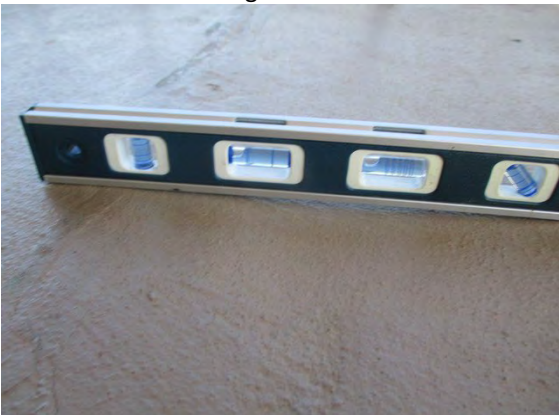
12

Level 3 Walkway Settled/Leaning At Right Side of Building

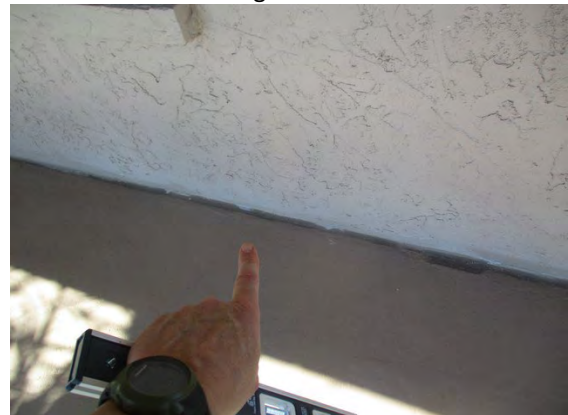
13

Level 3 Walkway Settled/Leaning At Right Side of Building

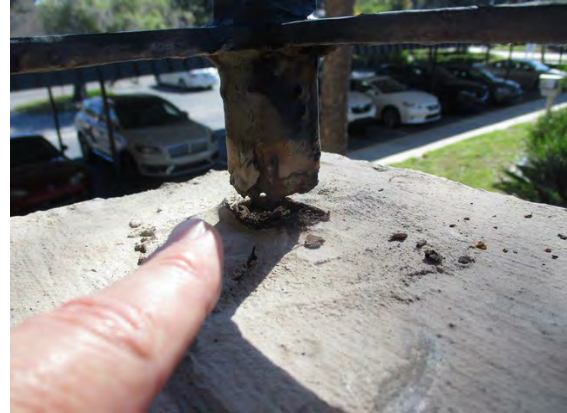
27 Level 2 Walkway Railing Corroded Multiple Areas

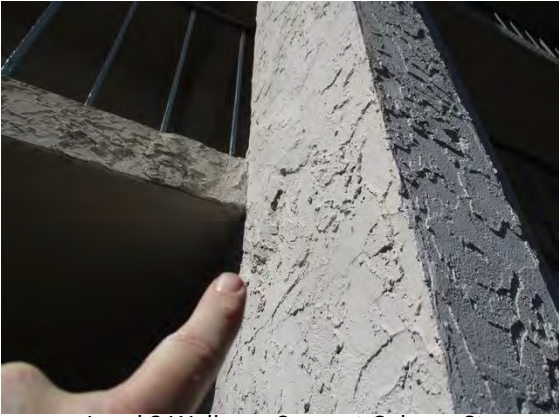
48 Level 2 Walkway Support Column
Shifted/Displaced Between 101 & 102
