Milestone Inspection – Phase 1

Prepared for the Board of Directors for the
Cordova Green of Largo COA

8681, 8693, 8605 Bardmoor Blvd Seminole, FL 33777

November 6, 2023

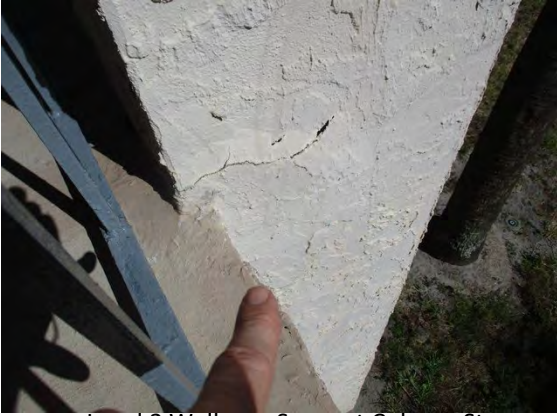
34 Level 2 Walkway Support Column
Shifted/Displaced ~1" Left of #202

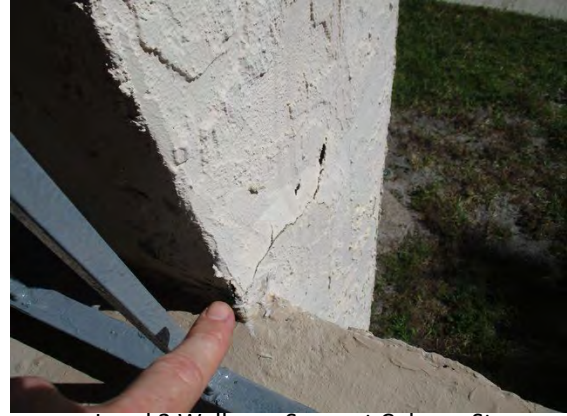
35 Level 2 Walkway Support Column Stucco
Cracked/Bulging Right of #206
