## Reserve Study

Prepared for the Board of Directors for the  
**Cordova Greens of Largo COA**

8681, 8693, 8605 Bardmoor Blvd, Seminole, Florida 33777

November 6, 2023

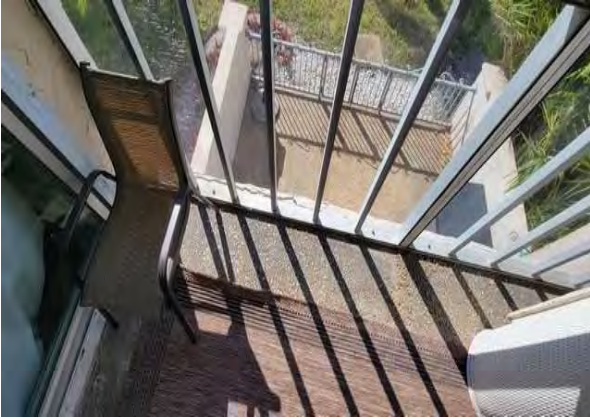
11 Unit 503 Balcony Cracking Overview

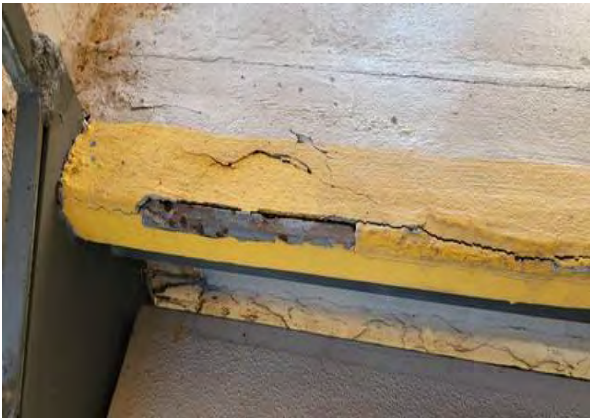
61 Damaged Walkway at Stairwell 2nd Floor Left Side

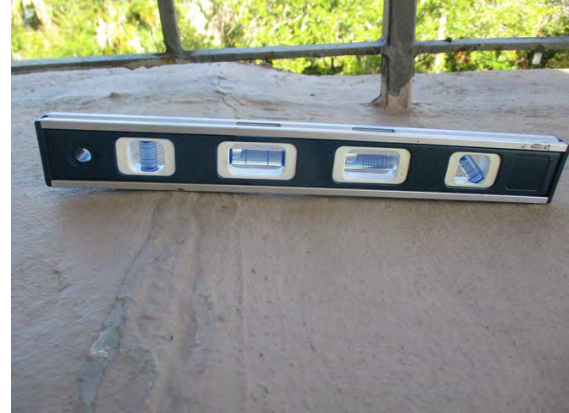
12

Level 3 Walkway Settled/Leaning At Right Side of Building

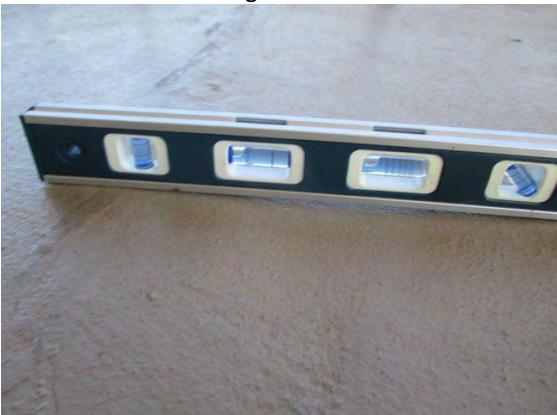
13

Level 3 Walkway Settled/Leaning At Right Side of Building

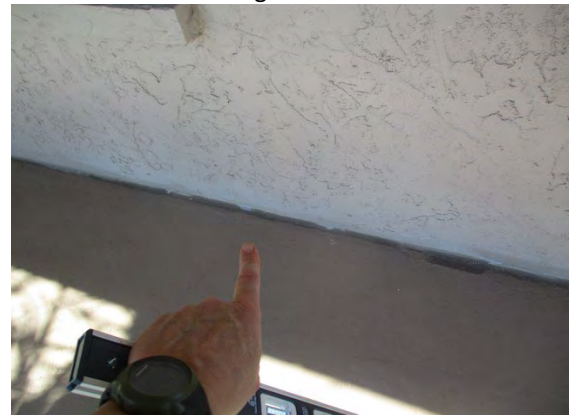
14

Level 3 Prior Repair For Separation at Walkway to Building Connection (Leaning)

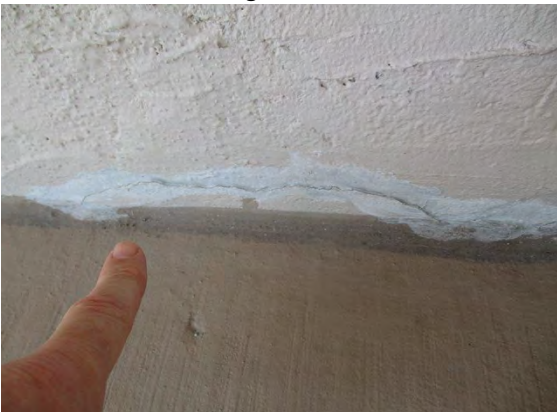
15

Level 3 Prior Repair For Separation at Walkway to Building Connection (Leaning)

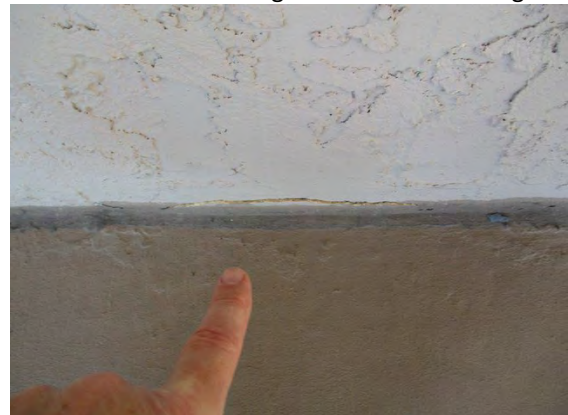
30 Level 2 Prior Repair For Separation at Walkway to Building Connection (Leaning)
