## **Reserve Study**

## **Cordova Greens of Largo COA**

8681, 8693, 8605 Bardmoor Blvd, Seminole, Florida 33777

**November 6, 2023**

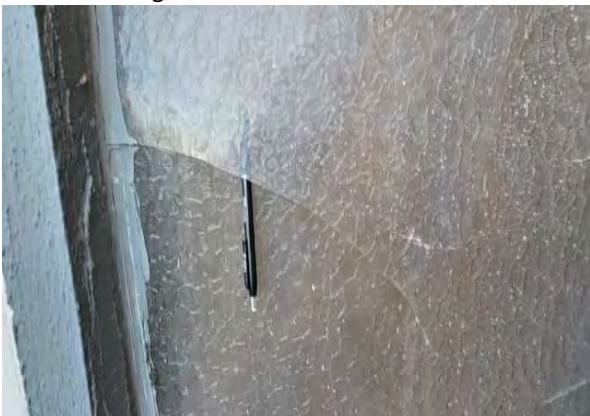
70 Broken Decroitive Window at 1st Floor Lobby Right Side Overview

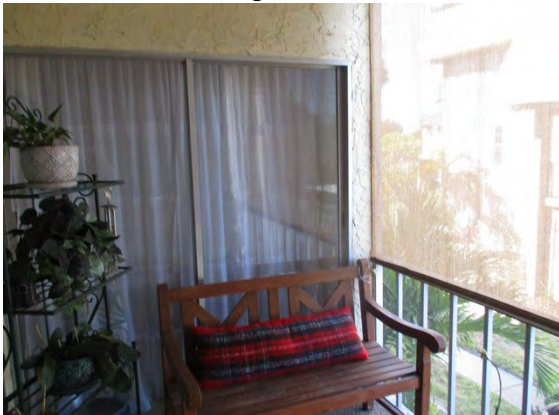
5 Unit 207 Balcony

5 Unit 207 Stucco Cracked/Bulging

6 Unit 207 Stucco Cracked/Bulging

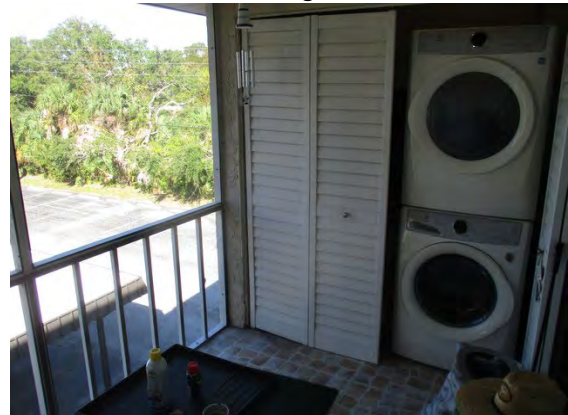
6 Unit 308 Balcony

7 Unit 308 Stucco Cracked/Bulging

8 Unit 308 Stucco Cracked/Bulging
